Interface characteristics of peeling-off damages of laser coatings

Yun Cui*, Kui Yi, Guohang Hu, Jianda Shao

Key Laboratory of Materials for High Power Laser, Shanghai Institute of Optics and Fine Mechanics, Chinese Academy of Sciences, Shanghai 201800, China

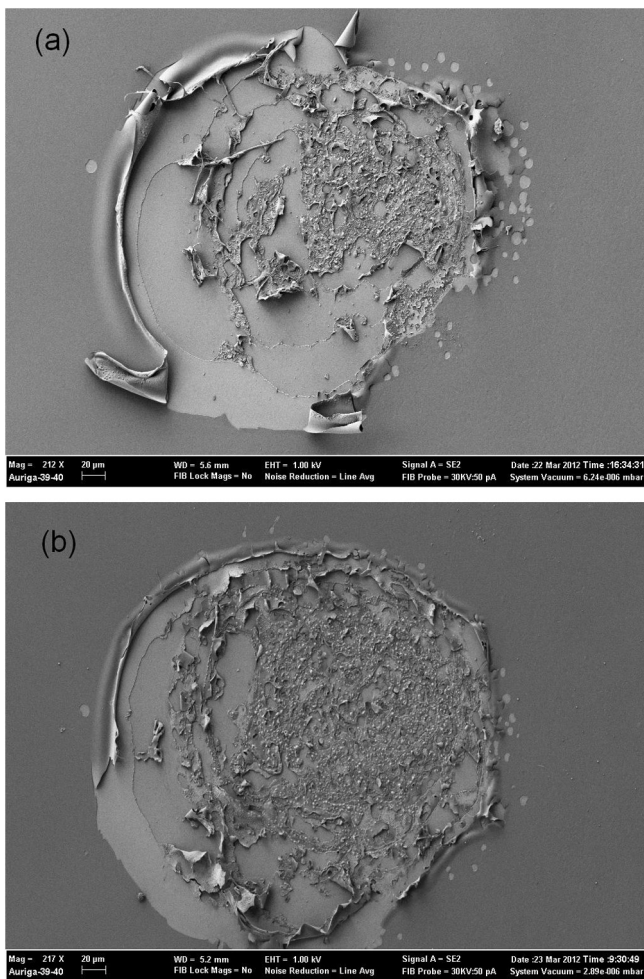
Peeling-off damages in the coatings were observed by FESEM, and results are shown in Figs. 1 and 2. Brighter areas in

the secondary electron images indicate HfO₂ or Ta₂O₅ material whereas darker areas indicate the SiO₂ material.

Fig. 1. SEM photographs of peeling-off damage in EBE-1: (a) one area and (b) the other area.

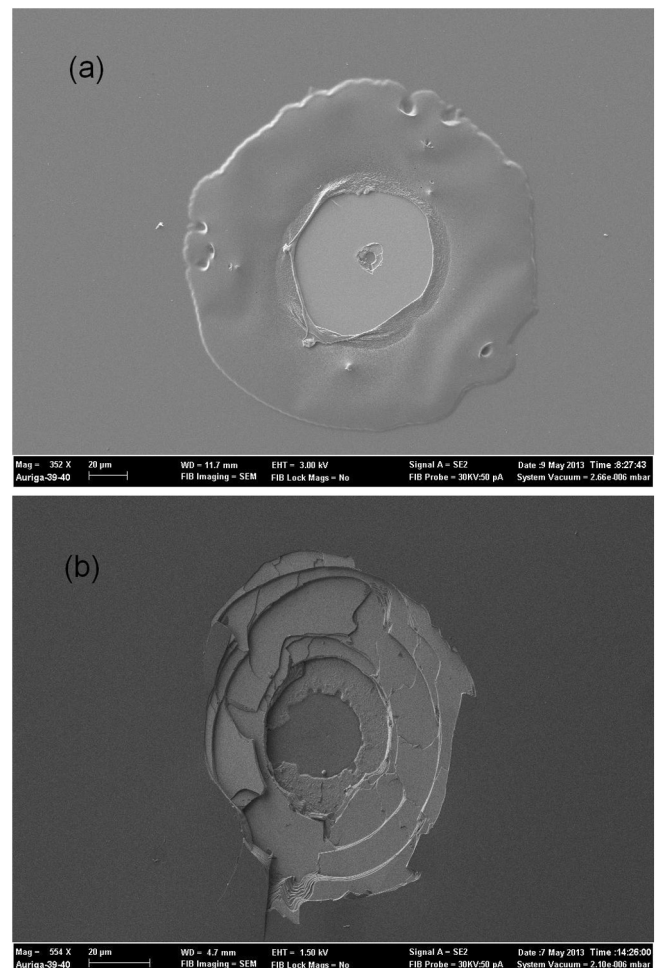
Fig. 2. SEM photographs of peel-off damage in (a) DIBS-1 and (b) DIBS-2.
