# A new finding on the *in-vivo* crevice corrosion damage in a CoCrMo hip implant

A detailed investigation was performed to characterize the fretting wear and corrosion damage to the neck component of a CoCrMo stem from a metal-on-polyethylene implant retrieved after 99 months. The stem was a low-carbon (0.07 wt%) wrought Co-28Cr-6Mo alloy with no secondary carbide phases in the matrix ( $\gamma$ -phase). The original design of the neck surface contained an intentionally fabricated knurled profile with a valley-to-peak range of approximately 11  $\mu\text{m}$ . Roughness measurements indicated that the tip of the knurled profile was significantly damaged, especially in the distal medial region of the neck, with up to a 22% reduction in the mean peak-to-valley height ( $R_a$ ) compared to the original profile. As a new finding, the channels between the peaks of the profile created an additional crevice site in the presence of stagnant body fluid within the head-neck taper junction. These channels were observed to contain the most severe corroded areas and surface oxide layers with micro-cracks. SEM/EDS, XRD and XPS evaluations identified the formation of  $\text{Cr}_2\text{O}_3$  a

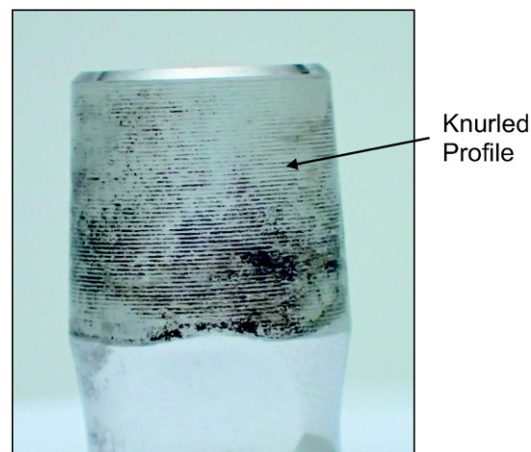
detergent with approximately 18% phenol) and left in fume cupboard for 48–72 h. During the decontamination process, biologic debris such as blood or proteinaceous films were carefully removed using a cotton bud without abrasion. An implant with metal-on-polyethylene (MOP) articulation was studied in this work. The head-neck taper interface of the implant was found to possess the most severe wear and corrosion damage in a cohort of thirty retrieved implants that were visually inspected. The implant had a 28 mm diameter Co-28Cr-6Mo femoral head coupled with a Co-28Cr-6Mo stem (CPT, Zimmer, Warsaw, Indiana, USA), and presented a 99-month service life in a 53-year old male patient of 107 kg. The neck component was a 12/14 taper ( $5^\circ 40'$ ) with a purposely generated knurled surface finish, as shown in Fig. 1. The implant was retrieved at revision surgery due to infection.

Fig. 1. Neck component of the retrieved implant made from CoCrMo alloy with a 12/14 taper ( $5^\circ 40'$ ) design.
