# Concrete alteration due to 55 years of exposure to river water: Chemical and mineralogical characterisation

Martin Rosenqvist<sup>a,\*</sup>, Alexandra Bertron<sup>b</sup>, Katja Fridh<sup>a</sup>, Manouchehr Hassanzadeh<sup>a</sup>

<sup>a</sup> Division of Building Materials, Lund University, Lund, Sweden

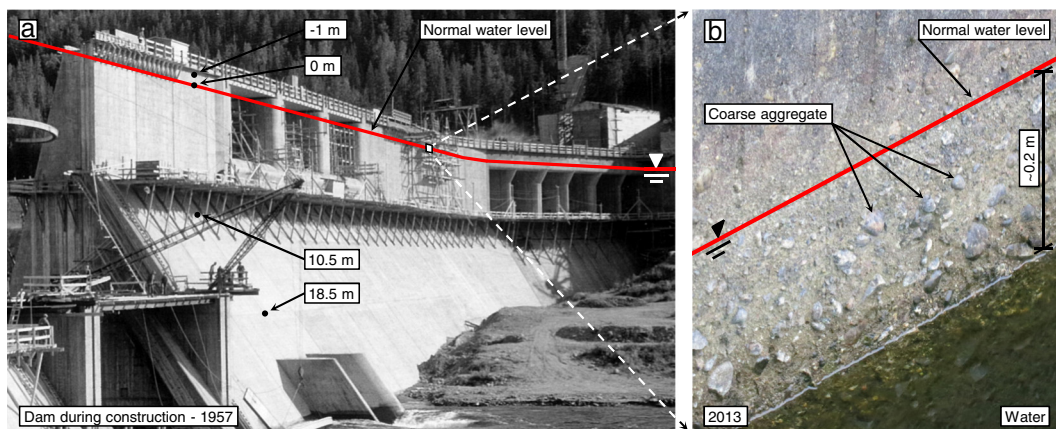
Many hydro power structures in cold regions suffer from concrete deterioration at the waterline [1–3]. Swedish hydro power plants are one example of such structures. Over the long term, progressive disintegration of the concrete surface leads to exposure of the coarse aggregate and later the reinforcing steel. Ultimately, surface deterioration of concrete may lead to reinforcement corrosion and reduced structural integrity.

water level (10.5 and 18.5 m); see Fig. 1a. As expected, exposed aggregate was visible at the waterline; see Fig. 1b. Far below the water level, the concrete surface was intact because the upstream face has not been exposed to frost action or ice abrasion due to a reservoir water temperature above freezing.

Fig. 1. Upstream face of the concrete buttress dam during construction (a). Black dots mark the locations of the concrete cylinders and the distances to the normal water level. Today, coarse aggregate is exposed at the waterline (b).
