Journal of the European Ceramic Society

Fractography of hardmetal dies used for the manufacture of polycrystalline diamond

Roger Morrell^{a,*}, Ken Mingard^a, Jonee Zunega^b

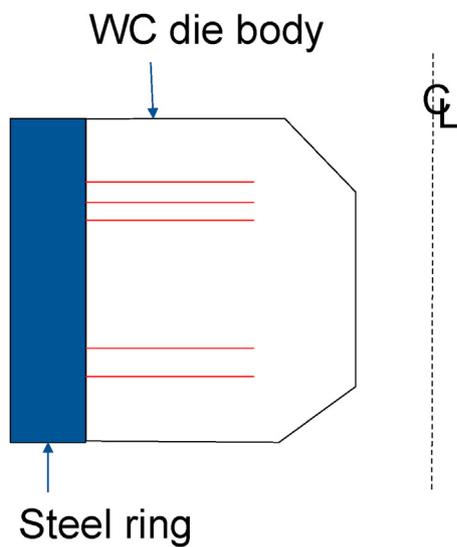
Having surmounted the dangerous challenge of breaking up a highly compressed die body and removing it from the retaining steel rings without inducing excessive collateral damage, it was immediately clear that the major process fractures within the die comprised two or three annular disc shapes about 10 mm thick in two zones, roughly opposite the ends of the cylindrical part of the bore, as shown schematically in Fig. 2. Relevant parts from three dies, two smaller and one large, were then selected and supplied for detailed examination. The most complete example retrieved is shown in Fig. 3.

Fig. 2. Schematic of the pattern of major cracks in a failed die body.

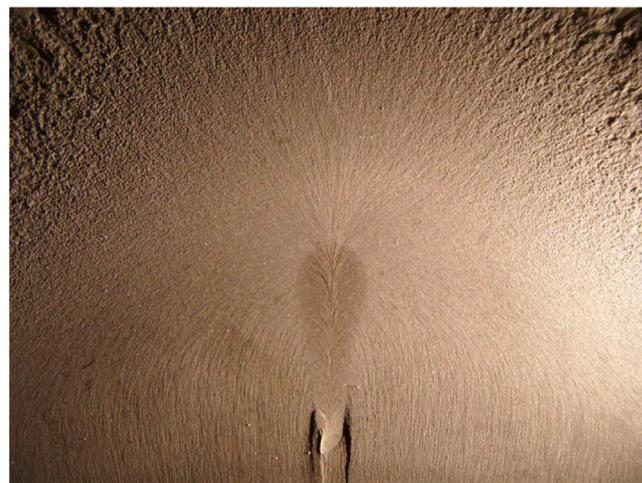
A consistent feature of the plate-like fragments was the presence of what could be interpreted as a very large fracture ‘mirror’ in the centre of which was a feature with ‘fountain’-like appearance of the fracture markings shown by the developing crack (Fig. 4). These markings appear to show that the crack emerged from the inner part of the die body as a narrow radially-moving fracture front

Fig. 4. A 'fountain' crack 'mirror' showing a narrow area of microhackle emerging from the interior of the die and radiating outwards, becoming rougher as a sign of acceleration, and becoming smoother as the lower parts propagate back towards the bore.

to roughly half way through the die wall thickness, and which subsequently 'broke' into a planar 'fountain'. Parts of the fracture front accelerate away towards the outside of the die, and reach a high velocity, as evidenced by the development of strong hackle. Propagation around the remaining annulus is then very rapid. Parts of the fracture front that 'fall' back towards the die bore come to a halt

These fracture patterns provide some useful information; that the origin is somewhere between the observed 'fountain' and the die bore, and that final fracture occurs while high axial compression is applied to the die bore region which halts the crack running back to the bore surface. The planar nature of these cracks is also

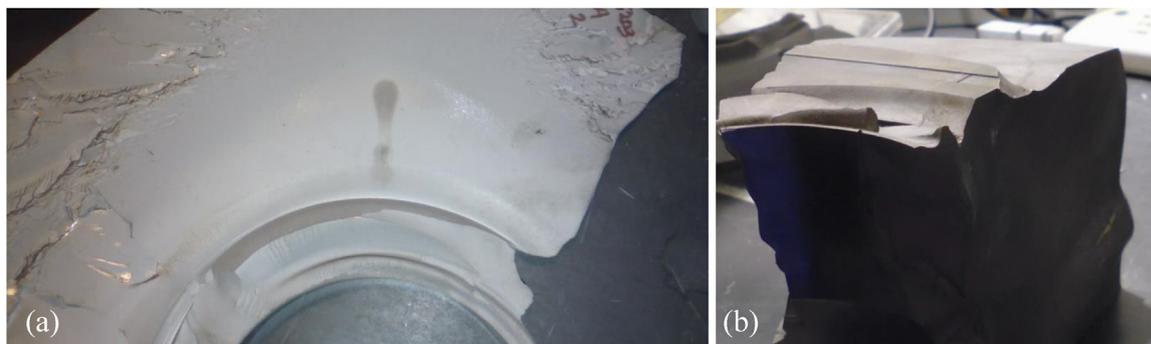
Fig. 3. Retrieved die fragments: (a) a planar region showing a distinct fracture pattern, and (b) a part of the unfractured matching bore block (inverted relative to (a)).
