Research Note

Endurance behavior of conductive yarns

Hans de Vries*, Kunigunde H. Cherenack

Philips Research, Eindhoven, The Netherlands

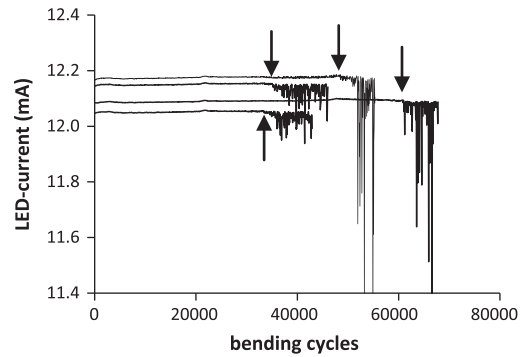
In the tests reported here only one row of LEDs is placed between the clamps and for the analysis only these four components are considered. This test set-up was designed to exert a force at the interconnect points between the LED and the conducting yarn (bold arrows in Fig. 3). During cyclic bending, LEDs are driven at a forward voltage of 4 V. The current through the LEDs is monitored to detect failures in the conductive path, defined as the moment when the current becomes irregular, as shown in Fig. 4.

Fig. 4. Current measurement during cyclic bending. Failure moments are indicated by the arrows. The ample displacement is 77 mm.

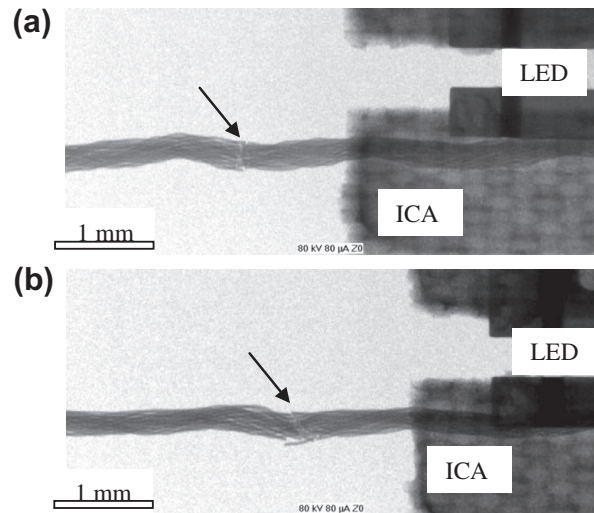
In Figs. 5 and 6 representative pictures of samples after testing are shown. The X-ray pictures show that the conducting wires are broken in the transition zone between the rigid globtop and the compliant textile (see the arrows pointing to cracks in the conducting yarn). These cracks are visible in all tested samples, even for the sample where cyclic testing was terminated since no electrical failure was detected after more than 1.5 million cycles. Fig. 6a shows a cross section of a complete LED attached to a conductive yarn.

Apparently, cyclic bending causes the conducting wires to break at the edge of the rigid globtop and the soft compliant textile. Each bending cycle causes the wire to bend at that transition point. Each

Fig. 5. X-ray pictures of samples tested at (a) 59 mm and (b) 35 mm displacement. Conducting wires are broken outside of the LED contact pad and ICA (see arrows).

subsequent cycle results in an accumulation of deformation (ϵ) until failure occurs.

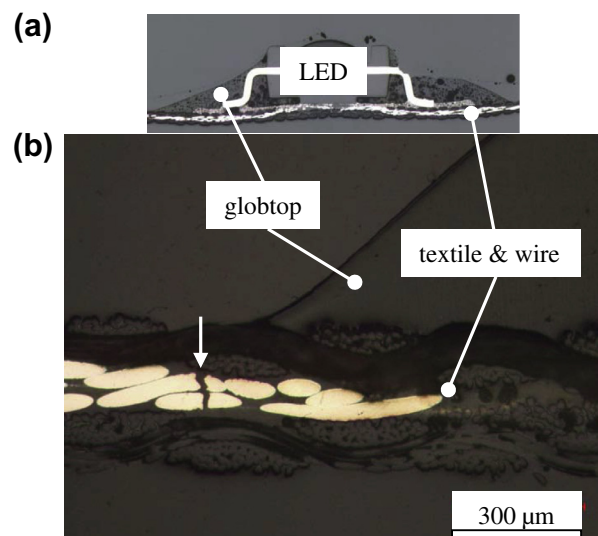
Fig. 6. (a) Cross section of the complete assembled product with a textile substrate, a LED and globtop. (b) Cross section of sample tested at 86 mm displacement. The broken wire is visible at the edge of the globtop (see arrow).
