ESIS TC24 Workshop "Integrity of Railway Structures", 24-25 October 2016, Leoben, Austria

## Analysis of the railway freight car axle fracture

Zoran Odanovic

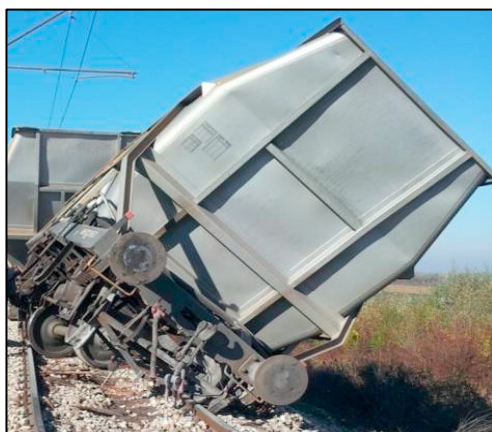
Fig. 1. Damaged railway freight car

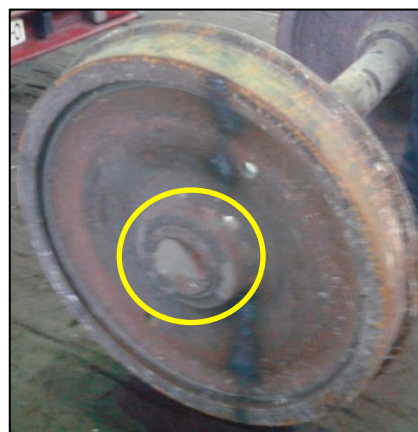
Fig. 2. The railway wheel and axle with signed fractured surface
