Procedia Structural Integrity 3 (2017) 33-40

Analysis of the mechanical behavior of a delayed coker drum with a circumferentially cracked skirt

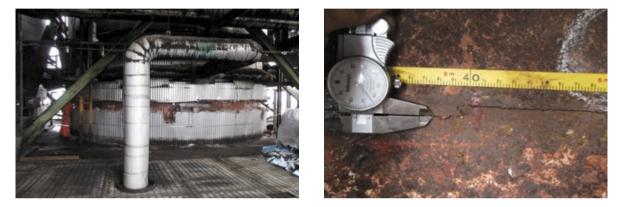
After eleven years of service, during a routine inspection, the thermal insulation was removed in the area of the skirt junction in all four drums in order to make thickness measurements, after that a cracking along the circumferential skirt junction was detected; the cracks ran aside of the welded joint in the skirt side. An example of the cracked area and the cracking is shown in Figure 1. At the time of inspection, in the four drums, the entire circumference was cracked and the fractured edge of the skirt showed different levels of misalignment between the fractured edges, as shown in Figure 2. There was also observed that there was an opening and closure movement of the mating crack surfaces In addition to the skirt junction cracking; bulging of the skirt, anchorage bolt pull out and corrosion under insulation were observed.

Fig. 1. Left: Coker drum with the thermal insulation removed in the skirt junction. Right: Cracking of the skirt junction running along the weld line in the skirt side.

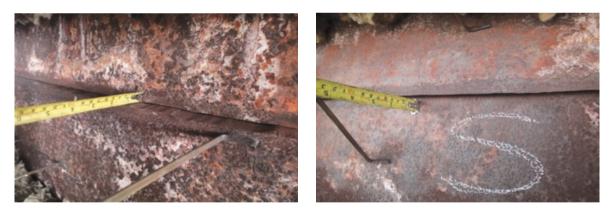
Fig. 2. Misalignment of the fractured edges of the skirt junction.

By visual observation of the drums in service, it was deducted that the misalignment was caused by the lateral displacement of the drums. It is worth to mention that the movement was fairly cyclic at a frequency of 1 Hz in the heating up stage of the drum operation. A literature survey pointed out that cracking of the skirt junction is a very common form of damage of the coker drums [Boswell (1997), Jani (2012), Schimidt (2012), API RP 571 (2013)], and it was known that these cracks are caused by the cyclic stresses induced by the differential thermal expansions of the pressure vessel and the skirt during the operational stages of the coker drum (load-heat up-quench-discharge), a mechanism referred as thermal fatigue [Boswell (1997), Jani (2012), Schimidt (2012), API RP 571 (2013)].
