# Failure Investigation: in Flight Loss of a Main Landing Gear Door of a Transport Aircraft.

G. Zucca, V. di Francesco, M. Bernabei, F. De Paolis\*

*Italian Air Force, Flight Test Centre, Chemistry Department, Military Airport M. De Bernardi, via Pratica di Mare, 00040 Pomezia (RM), Italy*

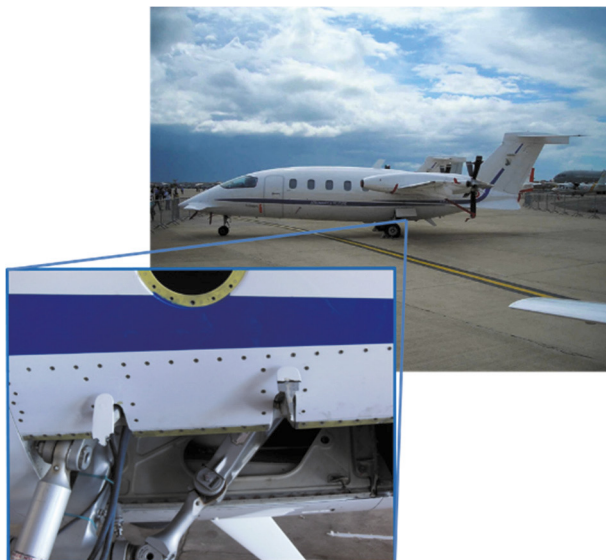
An executive transport military aircraft assigned to the 14<sup>th</sup> Support Wing, Pratica di Mare Air Force Base, experienced loss of the main landing gear (MLG) left door during a standard flight (Fig. 1). In the aftermath of this serious occurrence, the Chemistry Department of the Italian Air Force (IAF) Flight Test Center was tasked to lead a technical investigation aimed to clarify the root causes for the failure and to recommend how to prevent similar

Fig. 1: Location of Main Landing Gear left Door.

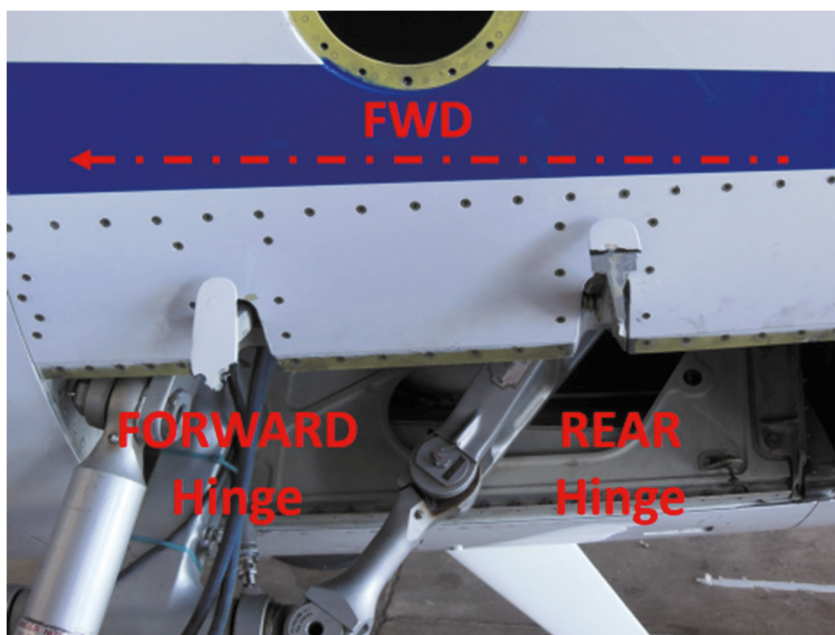
The investigation was carried out in agreement and collaboration with the representatives of the manufacturing company (OEM) and with the Support Wing maintenance personnel. The activity was focused on the hinges fracture surfaces connecting the door to the fuselage. In particular, the rear hinge is actuated through a leverage directly linked to the landing gear opening mechanism, while the forward one is only hinged to the fuselage (Fig. 2).

Fig. 2: Detail of Main Landing Gear Door.
