2016,28(5):863-872

Analyzing hydro abrasive erosion in Kaplan turbine: A case study from India^{*}

Anant Kr. RAI, Arun KUMAR

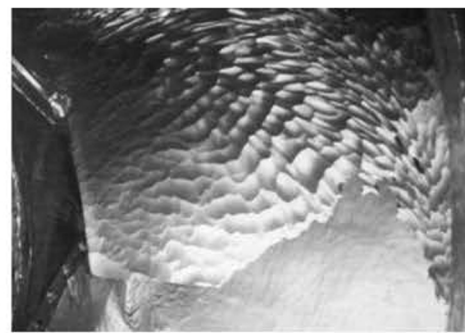
(a) Eroded Chilla turbine blade in trailing side

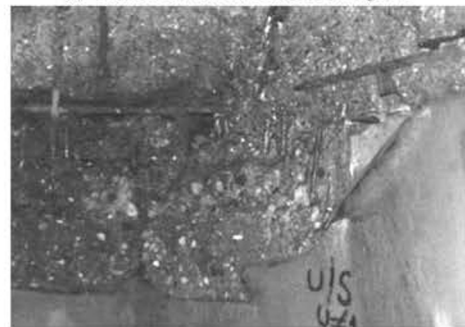
(b) Concrete exposed in eroded runner chamber

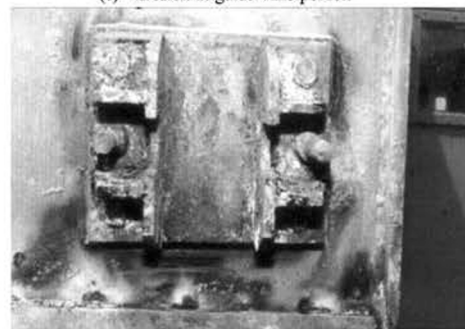
(d) Erosion in intake gate
