# Generation mechanism of large-size invisible defects on Si epitaxial wafers

Kyuhyung Lee\*, Jungkil Park, Jungwon Shin, Jayoung Kim, Heebog Kang, Boyoung Lee

Research Center, LG Siltron Inc., Gumi-si, Gyeongsangbuk-do 730-350, Korea

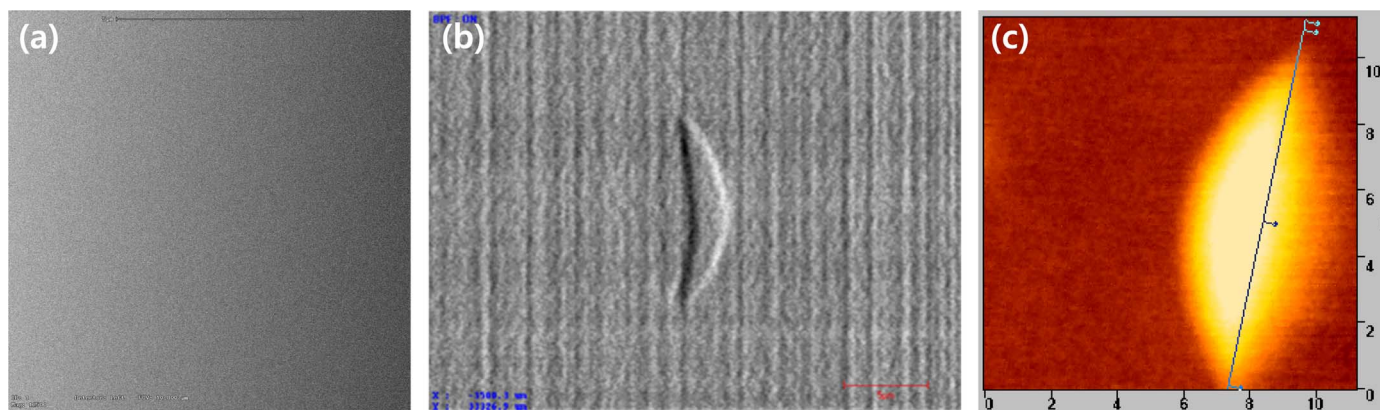
Fig. 1. Same epi defect images of (a) SEM, (b) MAGICS, and (c) AFM.

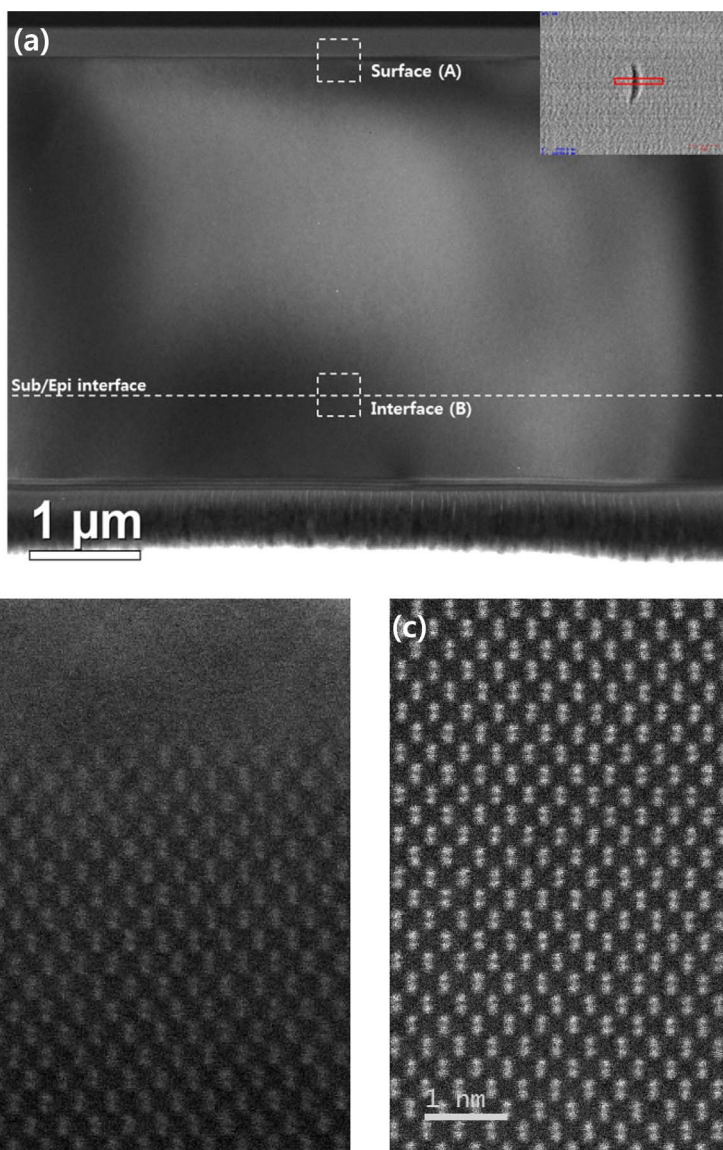
Fig. 2. Cross-sectional TEM images of invisible epi defect: (a) Low magnification bright-field TEM and HR-STEM images of (b) the surface and (c) heavily boron-doped substrate/epi layer interface region of the defects. Inset of (a) shows the defect image of the MAGICS tool and red rectangle region indicates position of the cross-sectional TEM sampling. (For interpretation of the references to color in this figure legend, the reader is referred to the web version of this article.)
