The Journal of Arthroplasty

Original Article

Damage Patterns at the Head-Stem Taper Junction Helps Understand the Mechanisms of Material Loss

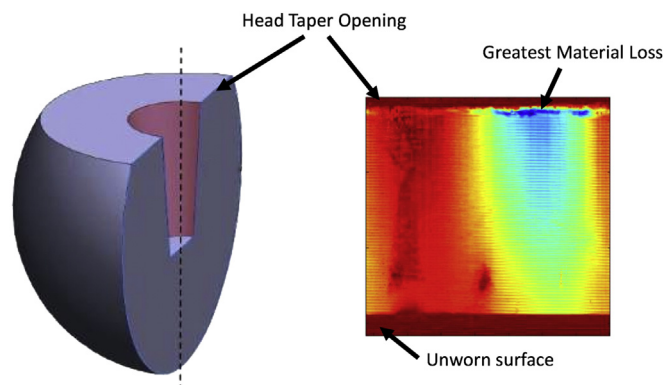
Fig. 1. Example of material loss map generated. Red regions represent unworn surfaces while blue regions represent areas with the greatest material loss.
