Engineering Geology

Investigation of a shallow slope failure on expansive clay in Texas

The shallow slope failure of a highway slope located in Fort Worth, Texas was investigated during this study. It was conducted using standard soil tests, geophysical testing, electrical resistivity tomography (ERT), extensive numerical modeling, and the finite element method (FEM). The strength parameters of the slope were determined using the direct shear (DS) and consolidated undrained (CU) triaxial tests.

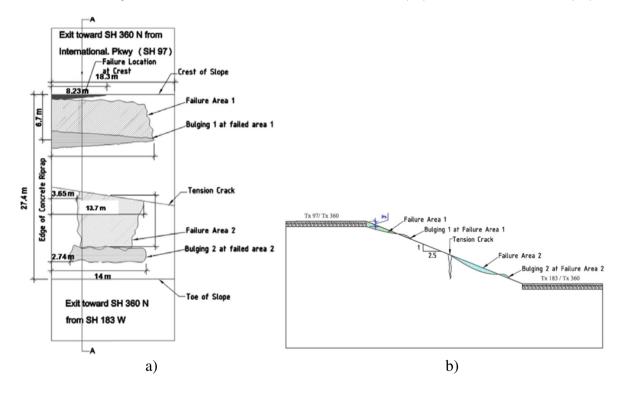
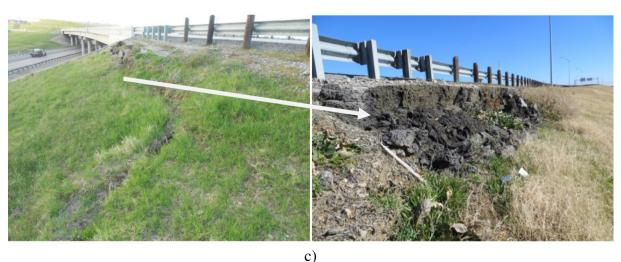
Fig. 1. (a) Failure Condition of SH 183 Slope (Plan View), (B) Section 1-1, (C) Failure near Crest.
