Lessons learned from a supercritical pressure BLEVE in Nihon Dempa Kogyo Crystal Inc.

Jiaqi Zhang, Delphine Laboureur, Yi Liu, M. Sam Mannan*

Mary Kay O'Connor Process Safety Center, Artie McFerrin Department of Chemical Engineering, Texas A&M University, College Station, TX 77843-3122, USA

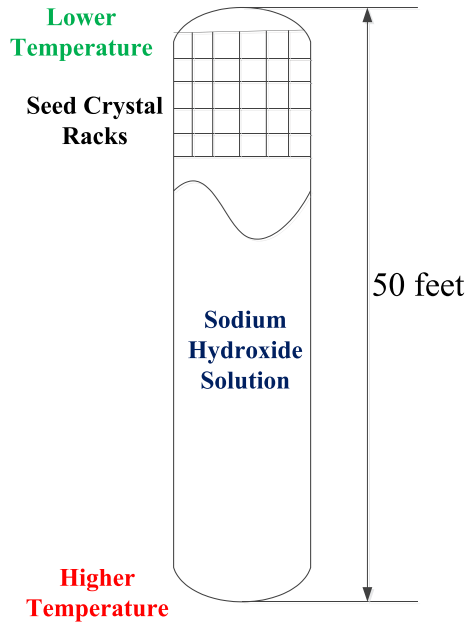
A schematic of the vessel is shown in Fig. 1. Seed crystal racks were installed at the top of the vessel with a lower temperature. When the fluid reached the crystal racks, the crystals precipitated and formed the desired product.

Fig. 1. Schematic of the vessel (based on description of CSB report).
