Severe accidental water vapour explosions in a foundry in China in 2012

Gang Li ^{a,*}, Tingchao Ji ^b

^a Fire & Explosion Protection Laboratory, Northeastern University, Shenyang, 110004, PR China

On 20th February 2012 a severe water vapour explosion occurred in China. The site of the explosion was an in-door molding pit of the Steel Casting Plant of the Heavy Machinery Co. Ltd., a part of the Anshan Iron and Steel Group in the Liaoning Province in north–east China. The pit, located inside a large factory building, had been in use for a number of years. When the pit was first made years ago, a large hole of square cross section was dug out of the ground and lined with a whole-welded steel box of 10 mm wall thickness. Then the inside of the steel box was lined with a 0.7 m thick water-proof concrete layer. The completed pit was 4.5 m deep and the side-wall lengths were about 12 m. When the explosion occurred, a conical stainless-steel ring weighing about 90 tonnes and intended to be the foundation of a water turbine was being cast in a sand mold. The ground water level was about 2 m below the ground level at the location of the pit. Hence, the bottom of the pit was 2.5 m below t

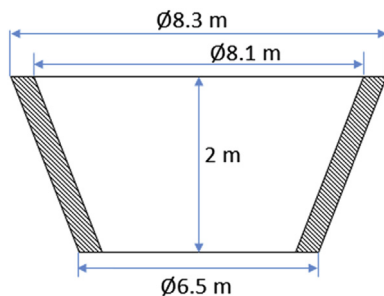
The explosion occurred when during the stainless-steel casting of a bottom ring of a hydraulic turbine in the large sand molding pit of Heavy Machinery Co. Ltd. The estimated weight of the ring was about 95 tonnes. The shape and main dimensions of the ring are shown in Fig. 1.

Fig. 1. The stainless-steel ring being cast in the sand mold at the moment of the water vapour explosion.

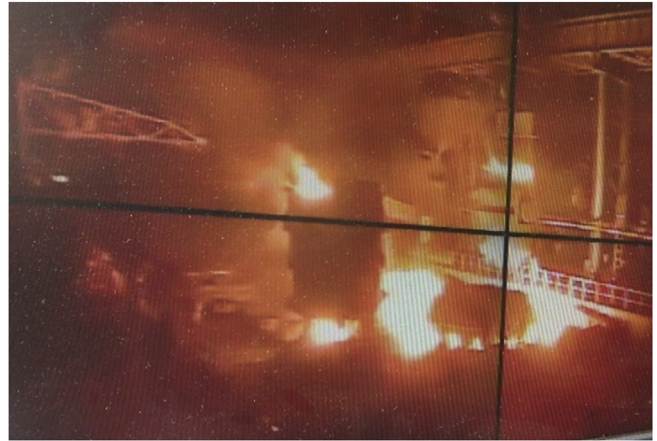
After about 30 min of pouring, shortly before the second ladle of molten steel had being emptied, an abnormal buzzing sound could be heard from the interior of the mold cavity. Suddenly everything in the mold cavity was thrown at least 5 m up in the air as one single entity. Then the ring-shaped sand mold with the molten metal in it turned over and hot sand and molten metal was shattered all over the place.

Fig. 2. . The sand mold with the stainless-steel metal being thrown at least 5 m up in the air at moment of the accident. The picture was taken by a video camera mounted in the production hall.

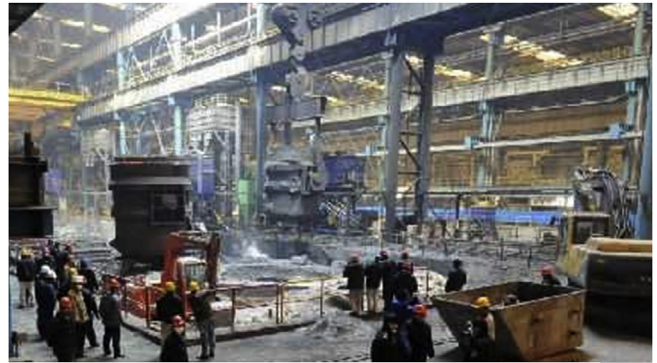
Thirteen people were killed, six seriously injured and 11 moderately/slightly injured. The molten steel and the hot sand caused serious damage to the power supply system, various

Fig. 3. Explosion site the large factory hall one day after the accident.

pipelines, the gantry crane, the excavator etc. Fig. 2 shows the moment when the accident happening. Fig. 3 shows the same scene one day after the accident. The cake-like residual (Fig. 4) has reached the pit ground and released a lot of heat deforming the steel bar seriously (see Fig. 5).

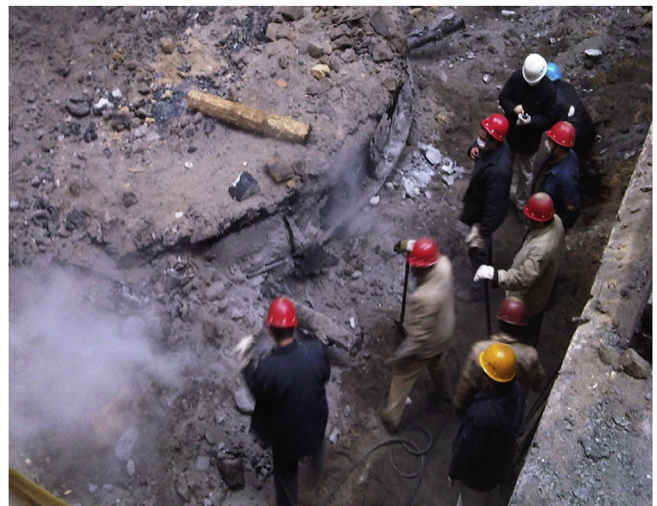
Fig. 4. Cake-like residues inside the molding pit after explosion.
