## Journal of Loss Prevention in the Process Industries

## A new approach on troubleshooting of cathodic protection: A case study

Technical Protection and Corrosion Engineering Department, Iranian Offshore Oil Company (IOOC), Iran

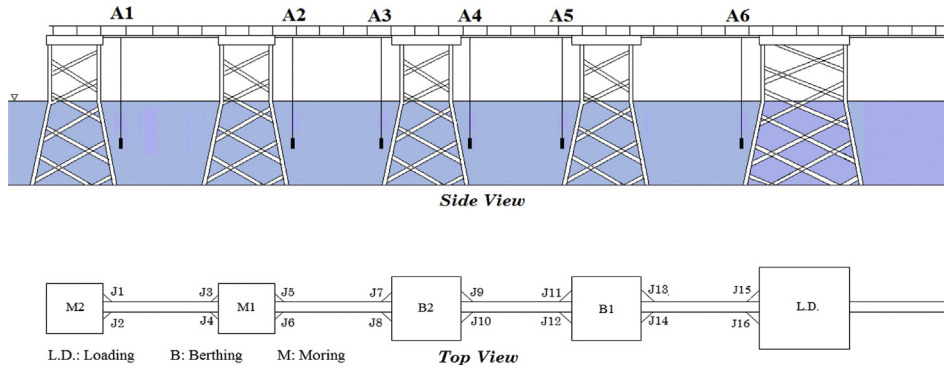
ICS which has been applied on a jetty shown in Fig. 1, cathodically protected the submerged parts of that. This ICS was comprising a rectifier/transformer with the maximum voltage of 50 V and the maximum current of 150 A and also six lead–silver submerged anode in order to distribute the current more uniformly through entire of immersed structures. For more assurances regarding to establish the CP circuit, the electrical connections which denoted by *J* connect the bridges to Loading (L.D.), Berthing (*B*), and Mooring (*M*) structures electrically. Since the minimum cathodic potential for full protection is  $-800$  mV with respect to (w.r.t) Ag/AgCl/Sea-water electrode based on NACE TM0497 (NACE, 2002), monitoring of cathodic potential of the jetty structure revealed that only the immersed Loading structures were near the fully protected conditions; and other underwater structures, including *B1*, *B2*, *M1* and *M2* were not protected and based on NACE TM0497 they were corroding. The problem was the lack of full protection criteria in *B1*, *B2*, *M1* and *M2*. Table 1 represents the potential of the jetty with respect to an Ag/AgCl/Sea-water reference electrode before troubleshooting. Fig. 2 schematically depicts distribution of rectified current among immersed 30inch lead–silver anodes. The history of the jetty and previous field data exhibited that, in the ordinary conditions, the jetty should be protected by applying a cathodic current about 100–105 A. Hence, first of all, the overall cathodic current was increased up to 103 A. However, this increase led to fully protection of underwater parts of Loading and *B1*, the other structures, especially the last one (*M2*)

Fig. 1. Schematic of side and top view of jetty including Loading, B1 (Berthing), B, M1 (Mooring), M2, and electrical joints from J1 to J16.

were not protected, and they were corroding based the existed criteria. This problem was dominant, even so, the applied cathodic current increased up to 135 A.

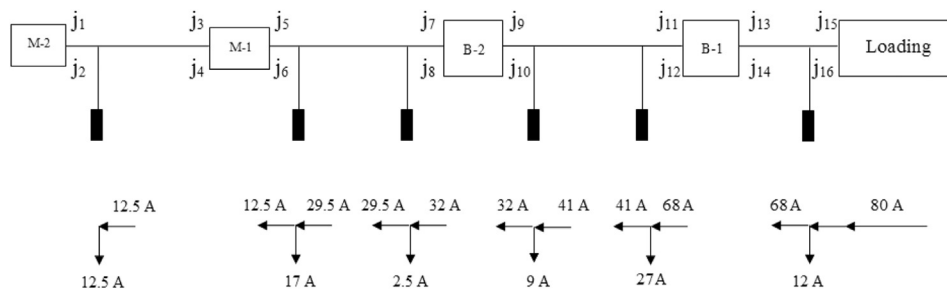
Based on the current distribution among immersed anodes shown in Fig. 2, the A3 anode consumed the least current amount. In this stage, the first assumption was about the A3 anode; and it was expected that the least current consumed here might be the reason of the failure. Therefore, a new one replaced this anode. Replacing this anode increased the current consumption of A3 anode from 2.5 A to 22 A. This increase in current consumption and enhancing to better current distribution over the immersed structure, however, did not eliminate the problem completely, but it led to increase in the cathodic potential of L.D. and B1 structures. After this step, lack of full protection in B1, B2, M1 and M2 structures was also evident hence another new anode named (A1') was added next to the first. The new one has been subjoined to increase the current consumption and distribution through M2 and M1 structure. In order to increase the cathodic current over the structures, the D.C. voltages of transformer/rectifier were also increased to 8.8 V from its initial value 7.5 V; therefore, this led to increase of the rectifier output current up to 103 A (Based on the history of structure potential measurements and previous data, the jetty should be fully protected by this amount of current). Further cathodic potential measurements were performed after complete polarization. Fig. 3 and Table 1 represent the new current distribution and jetty cathodic potentials, respectively, after first step.

Fig. 2. Schematic distribution of rectified current among immersed lead–silver anodes before troubleshooting.
