Study on the cause and treatment of rail corrugation for Beijing metro

Hougui Zhang*, Weining Liu, Weifeng Liu, Zongzhen Wu

School of Civil & Architecture Engineering, Beijing Jiaotong University, Beijing 100044, China

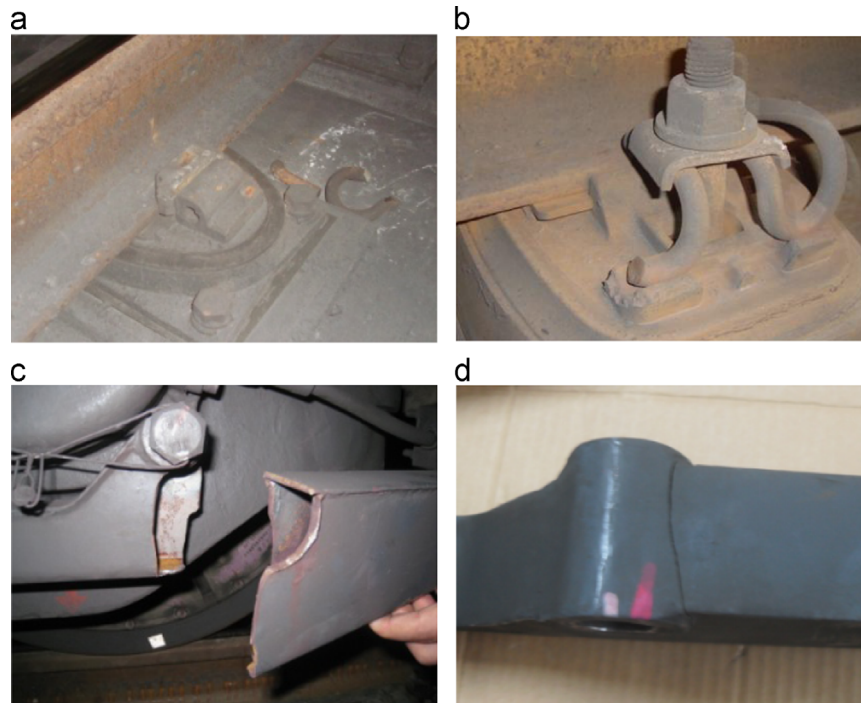
Fig. 1. Damaged parts of track and rolling stock caused by corrugation. (a) The clips drop off (track), (b) the clips broken (track), (c) parts of bogie frame cracked (train) and (d) parts of bogie frame cracked (train).

15–20 dB (A) in the sections where rail corrugation was found. Operation safety is becoming a concern due to an increase in drop off and broken clips within the fastening system which are found every day in severely corrugated sections. Cracks in bogie frames and wheelset components have also been observed, see Fig. 1.

Rail corrugation posed a serious problem for track maintenance personnel of Beijing metro. Currently, the primary method for controlling corrugation is to grind the rail at regular intervals. However, as corrugation develops so fast in some sections that the rail had to be renewed because of the frequent grinding procedure.
