# Generation of transfer film and its effects on wear mechanisms in alumina conveying pipeline of mild steel

A.A. Cenna<sup>a,\*</sup>, K.C. Williams<sup>b</sup>, M.G. Jones<sup>b</sup>, N.W. Page<sup>a</sup>

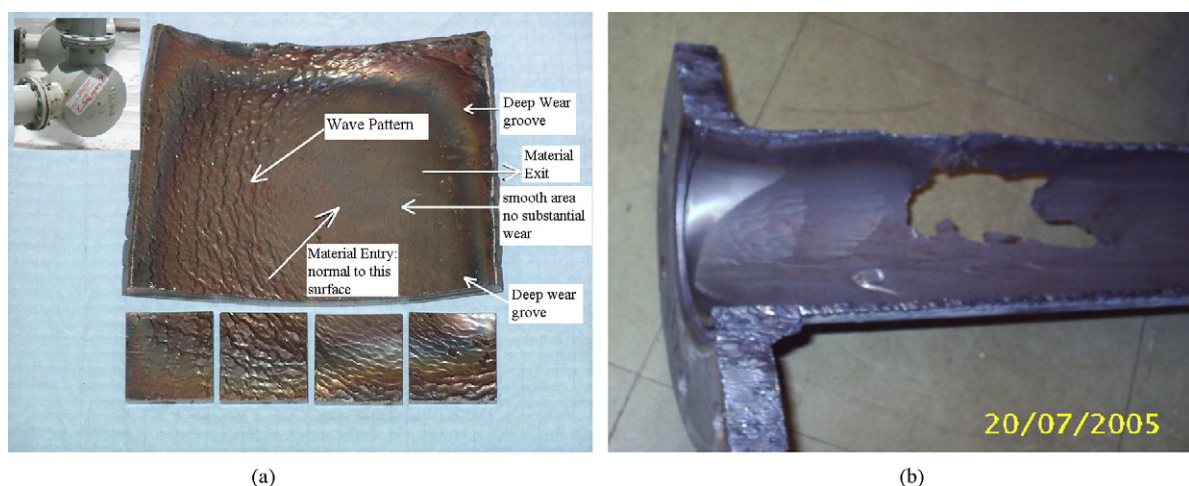
To understand the severity of wear in the industries, Fig. 1 shows wear samples from an industrial pneumatic conveying pipeline used to transport primary alumina [9]. Fig. 1a shows the section of a bend and Fig. 1b shows the straight section of the pipeline. Fig. 1a shows a typical example of the bend protected by the particles accumulated in the bend. On the other hand, Fig. 1b showed the severe wear in the section after the bend. Observation of these sections revealed that there was no rust in certain areas of the wear sections

even though they have been exposed to the atmosphere for a long period of time (more than 1 year). It was this observation that suggested that some type of protective coating (i.e. transfer film) has been formed in the conveying process which was protecting the mild steel surface from oxidation.

Fig. 1. Critical wear areas of an industrial pipeline and bend (a) bend section (b) straight pipe section after the bend.
