AAHKS Symposium: Corrosion at the Head-Neck Junction: Why is this Happening Now?

## Treatment of the Failed Modular Neck Stems: Tips and Tricks

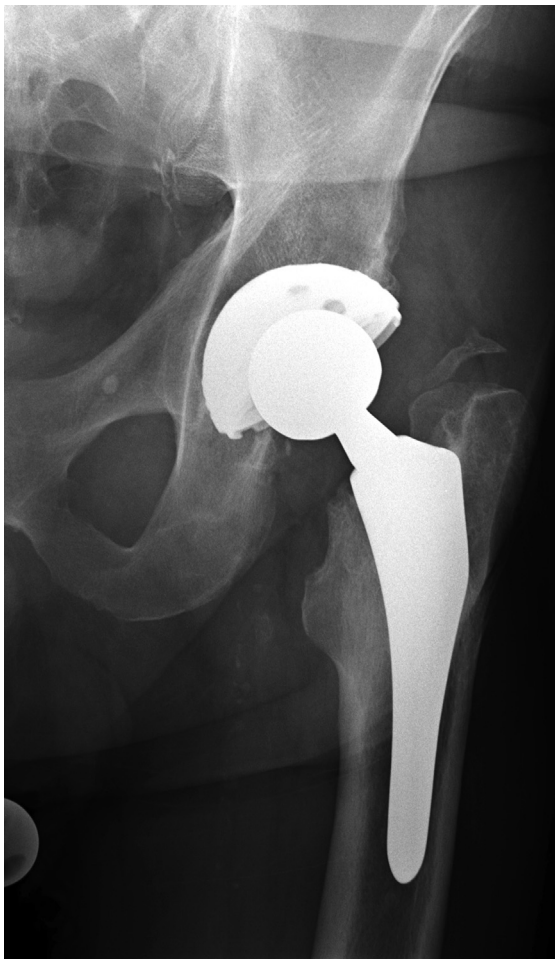
**Fig. 1.** Anteroposterior radiograph of a 56-year-old male patient who presented 2.5 years after undergoing left primary THA with a recalled modular femoral component demonstrates satisfactory position and alignment. THA, total hip arthroplasty.

being negative. Metal ion levels were obtained from the serum and revealed chromium (Cr) 2.2  $\mu\text{g/L}$  (reference interval 0.1–2.1), and cobalt (Co) 3.6  $\mu\text{g/L}$  (reference interval 0.0–0.9). Metal artifact reduction sequence magnetic resonance imaging demonstrated periarticular fluid distending the left iliopsoas tendon sheath with a loculated fluid collection abutting the posterior cortex of the greater trochanter representing a possible seroma. Using the risk stratification algorithm developed by Kwon et al [13], the patient's risk was high, and revision surgery was recommended. On revision surgery, there was significant corrosion observed at the tapered junction of the modular femoral neck and stem (Fig. 2). Revision surgery included revision of the liner, head, and femoral stem using a highly cross-linked polyethylene liner, 36-mm BioloX delta ceramic head (CeramTec GmbH, Plochingen, Germany) with a –3 mm titanium option taper adapter, and a cementless modular, tapered revision stem augmented with cerclage cables. Take home points from this case include the following:

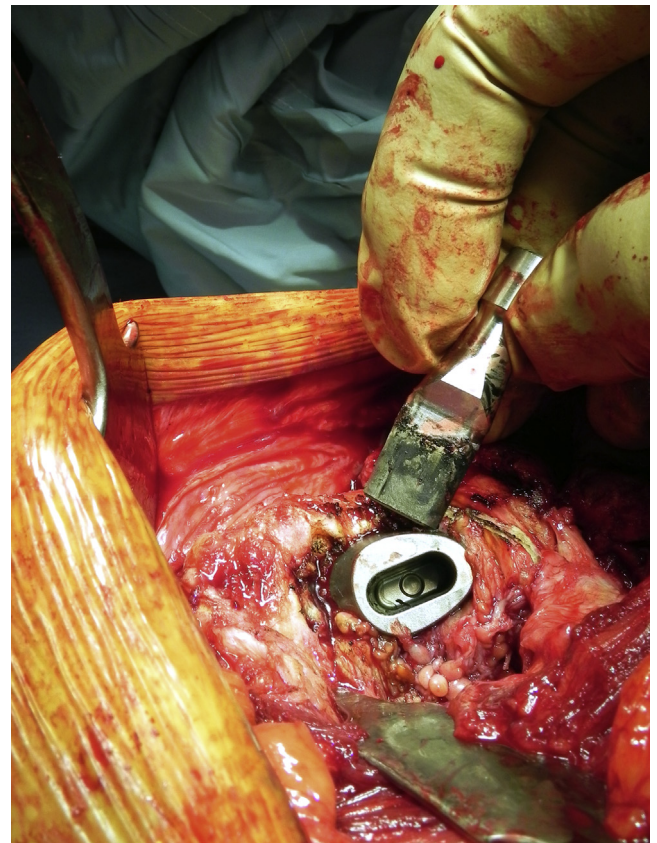
**Fig. 2.** Intraoperative photograph at the time of revision surgery demonstrates extensive corrosion at the stem body-modular neck tapered junction.
