## Ceramic Femoral Component Fracture in Total Knee Arthroplasty: An Analysis Using Fractography, Fourier-Transform Infrared Microscopy, Contact Radiography and Histology

Alexander P. Krueger, MD <sup>a</sup>, Guralp Singh, FRCSEd(Orth) <sup>a,b</sup>, Frank Timo Beil, MD <sup>c</sup>, Bernd Feuerstein, PhD <sup>d</sup>, Wolfgang Ruether, MD <sup>c</sup>, Christoph H. Lohmann, MD <sup>a</sup>

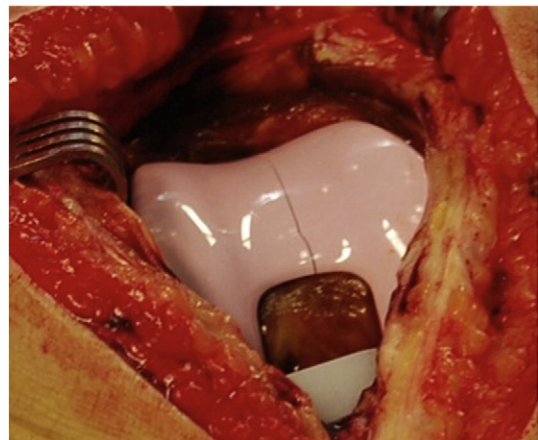
The femoral component showed a complete longitudinal fracture in the midline, though firmly attached to the underlying cement mantle (Fig. 1). After removal of the ceramic component a complete, intact femoral cement mantle was found. There were no flaws in the cementation. The cement–bone interface showed adequate indentation of the polymethylmethacrylate (PMMA) cement into the cancellous bone.

**Fig. 1.** Midline longitudinal fracture of the ceramic femoral component.
