# Fractures of a Single Design of Highly Cross-Linked Polyethylene Acetabular Liners: An Analysis of Voluntary Reports to the United States Food and Drug Administration

Michael P. Ast, MD, Thomas K. John, MD, Anthony Labbisiere, Nicolas Robador, MD, Alejandro Gonzalez Della Valle, MD

Department of Orthopaedic Surgery, Division of Adult Reconstruction and Joint Replacement Surgery, Hospital for Special Surgery, New York, New York

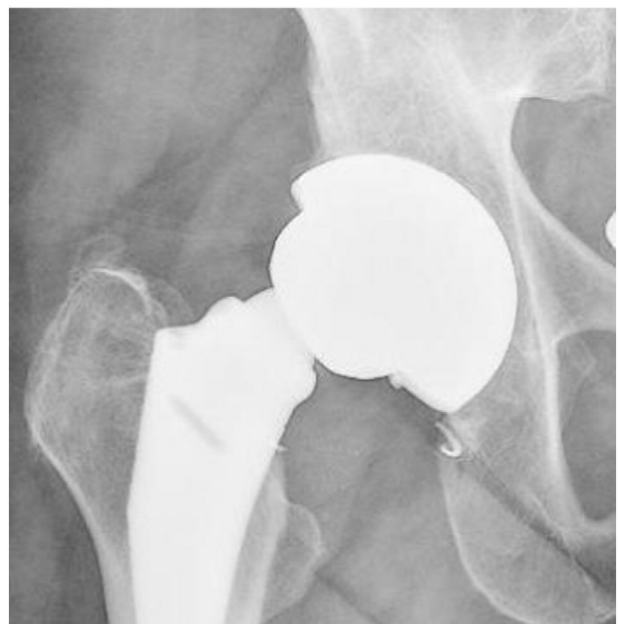
with clicking, occasional creaking, and squeaking coming from the right hip. Physical exam demonstrated a coxalgic gait, and the right hip had a painful and limited range of motion. Plain anteroposterior radiographs of the pelvis demonstrated eccentric position of the right prosthetic femoral head within the acetabular component. Also noted were several small fragments of metallic debris inferior to the acetabular component (Fig. 3). Deep joint infection was ruled out following a negative workup including a normal erythrocyte sedimentation rate (ESR), C-reactive protein (CRP), and fluoroscopic guided joint aspiration.

Differential diagnoses included: hip dislocation, severe polyethylene wear, and fracture/dislodgement of the liner [14]. Radiographs in AP, lateral and Judet views ruled out dislocation of the femoral head. The inclination of the acetabular component was 56 degrees. In addition, a CT scan of the hip demonstrated 20 degrees of acetabular anteversion and 17 degrees of femoral anteversion [15].

**Fig. 3.** Antero-posterior radiograph view of the right hip shows a well fixed, vertically oriented acetabular component. There is eccentric positioning of the femoral head and fragments of the locking ring are present in the inferior portion of the cup.
