Case Report

Failure of the Rotating-Hinge Knee Megaprosthesis

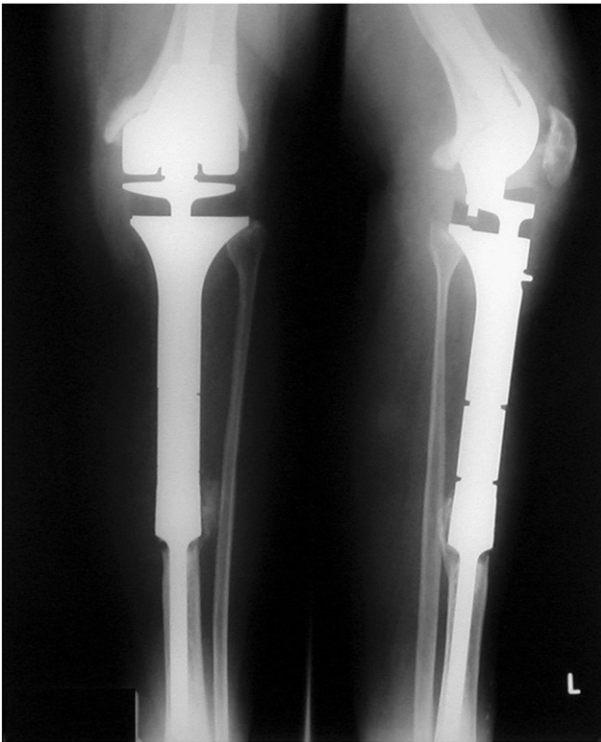
cruciate ligament and medial collateral ligament. Fibular head and lateral collateral ligament, on the other hand, were reserved. Cemented United oncology modular knee system (United Orthopedic Co., Hsinchu, Taiwan) was used. Extracortical bone bridge was applied for the tibial side (Fig. 1). The prosthesis design included several major components: a metal femur component with a 7° valgus stem, a tibial PE stopper, a metal tibial stem with a metal hinge axle-yoke mechanism, and a full-PE tibial main body. Postoperatively, the patient received regular follow-up at our clinics without complications.

Fig. 1. Radiographs of the left knee in anteroposterior and lateral views show status post-wide excision of tumor and total knee arthroplasty with rotating hinge megaprosthesis.

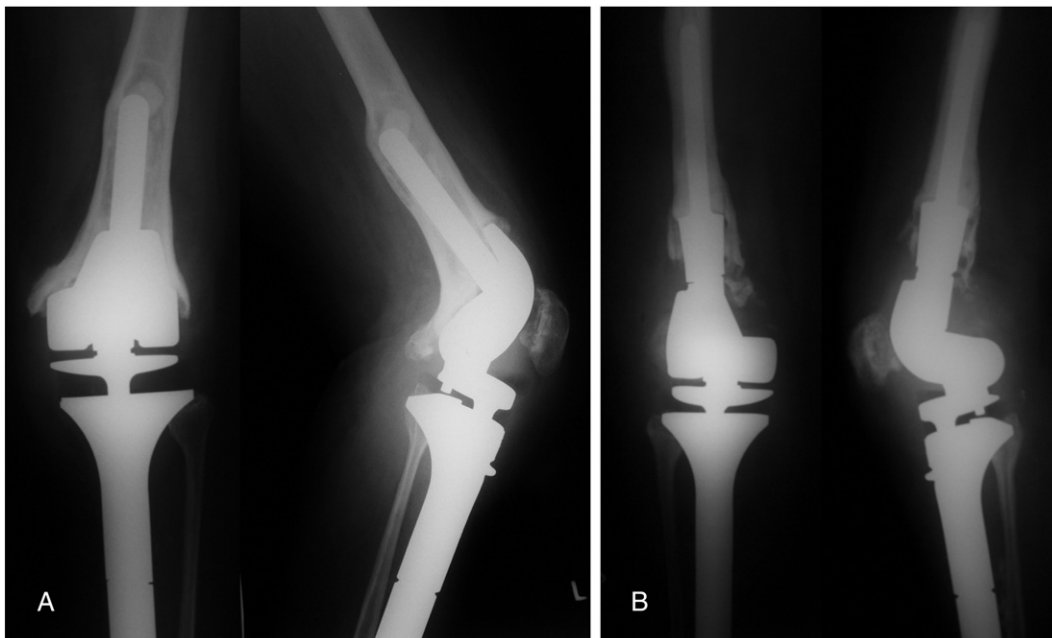
Unfortunately, 5 years after her operation, she heard a crackle sound while walking and felt pain and a sudden locking in her left knee. She visited our outpatient clinics again and physical examination revealed some joint effusion with limited range of motion of left knee. There were no local erythema, heat, swelling, or fever noted. Femoral stem loosening with varus, posterior drift and femur posterior cortex remodeling and thickening were seen in radiography (Fig. 2A). The joint space was symmetrical and there was no femoral component migration. During revision surgery in November 2003, we noted wearing, scratching, and slight delamination over all articulating surfaces of tibial PE stopper. The fracture occurred at inner cut-out region of the PE stopper, which featured as interior sharp margin and long transverse pattern (Fig. 3A, C). Furthermore, the PE bushing was worn and the femoral component was loosened with many granulation tissues within the joint.

Fig. 2. (A) Radiographs of the left knee in anteroposterior and lateral views show knee prosthesis femoral stem loosening with varus and posterior drift and femur posterior cortex remodeling and thickening. (B) Radiographs of the left knee in anteroposterior and lateral views show satisfactory rotating hinge total knee megaprosthesis and allografts.

Removal of the broken tibial PE stopper, the tibial bearing component, and the loosened femoral component was done. Granulation tissues were debrided. A new femoral component with 2.5-cm segmental part was inserted and cemented. Extracortical bone bridge was also applied. The tibial PE stopper with tibial bearing component was changed (Fig. 2B). The soft tissues from the
