Adverse Local Tissue Response Lesion of the Knee Associated With Morse Taper Corrosion

William C. McMaster, MD,* and Jay Patel, MD†

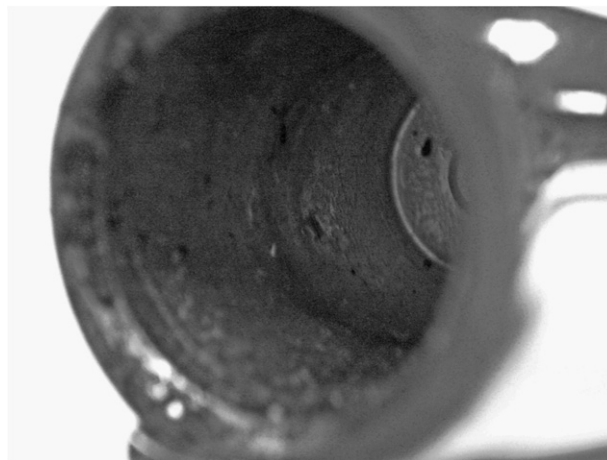
Fig. 2. The disassembled taper shows the black encrustations on the femoral stem component of the join. Similar changes were also evident on the walls of the mated distal femoral component.

mium and molybdenum oxides, which can be corrosion products of a cobalt/chromium/molybdenum alloy. The taper junction was very tight with no evidence of taper disassociation and required strong force to disengage it. Upon separating the taper, it was immediately apparent that corrosion was present within it with discoloration and etching of both sides of the join. An extensive capsule debridement was performed. Permanent sections of the resected capsule showed sheets of eosinophilic fibrous tissue devoid of cells and no evidence of aseptic lymphocytic-dominated, vasculitis-associated lesion (ALVAL). Multiple cultures of the joint fluid and capsule showed no bacterial, fungal, or TB growth. As no Co- and Cr-containing rotating platform hinge device is currently Food and Drug Administration approved in the United States, a new distal femoral component was applied to the original ingrown femoral stem as a temporary fix. The hinge components were then reassembled. The areas of full thickness necrotic skin were debrided and covered with a gastrocnemius flap and eventually split skin grafting. The prior severe pain was immediately relieved. At 8 months after the exchange procedure, serum chromium was 0.7 µg/L, and cobalt was 2.3 µg/L. There are no clinical signs of the previous syndrome, and he retains the revised components. The patient continues to be employed.
