# Repeated Early Failure of a Newly Designed Hinged Knee System

**Abstract:** We report a case of acute and recurrent accelerated wear of the polyethylene bushings of the hinge mechanism in the Zimmer Segmental Knee System. This resulted in an unacceptable recurvatum deformity leading to multiple revision knee operations, which was unexpected in a modern design hinged knee system. A custom modification of the original design was used to prevent further recurvatum deformity. The current design of the hinge post mechanism in this system appears to be inadequate, which led to the development of a significant recurvatum deformity in our patient. Surgeons should be aware of this potential complication when considering the use of this revision knee system. **Keywords:** total knee arthroplasty, implant failure, polyethylene wear, revision, hinged knee system.

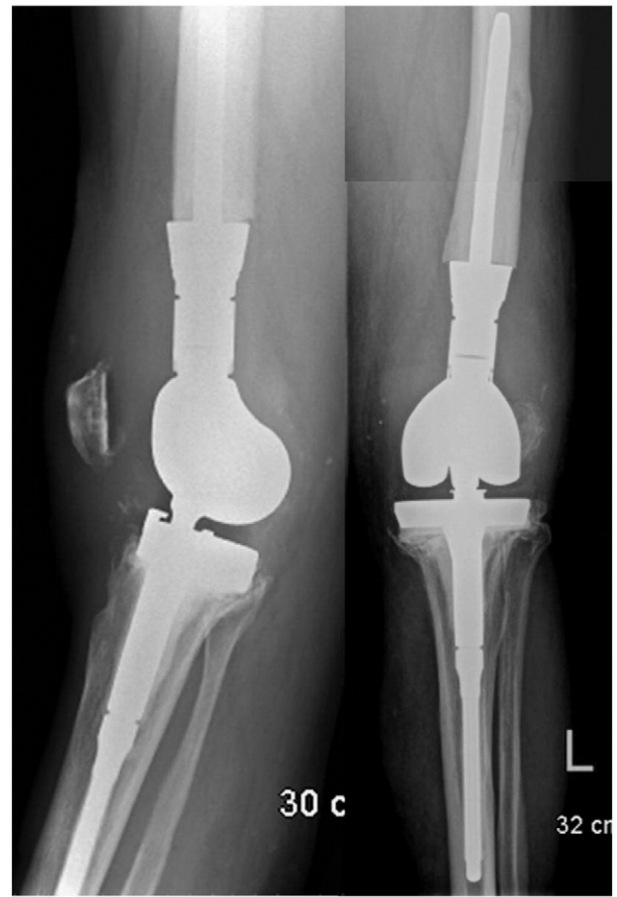
Six weeks later, the patient presented to the clinic with complaints of “knee buckling.” On examination, the patient’s knee went into painless recurvatum of 20° on ambulation and 10° with elevation of the foot in a supine position (Fig. 1). Knee flexion was 100°. This system uses a unique bushing design that includes a mechanism for blocking hyperextension, rather than a separate “bumper” as seen in traditional rotating hinge designs. We postulated that the bushing had failed prematurely, and the patient was scheduled for revision knee surgery. Zimmer representatives and the system design engineer were present during the revision (June 2011). Intraoperatively, it was noted that the plastic bushing that prevents hyperextension had undergone severe deformation around the hinge. The polyethylene blocking piece had deformed both along the circular contact area with the axle and anteriorly where it was supposed to prevent recurvatum (Fig. 2). Because the tibial and femoral components remained well fixed and in good position, it was elected to insert a new set of polyethylene bushings, axle, and tibial insert, assuming the prior one had failed because of a potential polyethylene imperfection. Intraoperatively, this corrected the recurvatum deformity, and the knee was closed as per standard protocol. After surgery, we were informed by Zimmer that this similar issue had happened in 2 other cases that they were aware of.

**Fig. 1.** Lateral and anteroposterior x-rays of the ZSKS showing significant recurvatum deformity.

Two weeks later, the patient presented again with an onset of a recurvatum deformity of 15° similar to the previous occasion. There was no history of trauma, and radiographs did not reveal any mechanical issues with the prosthesis. Considering the recurrent and accelerated failure of the polyethylene blocking piece, it was decided to custom design a modification to the femoral implant to avoid full revision of his well-fixed components. The ZSKS allows for isolated exchange of the distal femoral component without having to revise the existing cemented stem construct. The custom-made piece was designed in consultation with the engineers of the ZSKS (Fig. 3). It was decided to fashion a positive “stop” in the system. This was done by adding a polyethylene button into a recess inside the box of the femoral component and adding a cobalt-chrome-raised bumper on the hinge post, which would contact the polyethylene button in full extension and, therefore, provide a mechanical block to hyperextension. In addition, the polyethylene bushings around the axle were also thickened to provide improved tolerances here. The other surgical option would have been to revise the whole implant to another salvage knee
