Ecological Engineering 68 (2014) 189-199

Deformation measurements and a stability analysis of the slope at a coal mine waste dump

Yong-Chan Cho, Young-Suk Song*

Geologic Environment Division, Korea Institute of Geoscience and Mineral Resources, Daejeon, Republic of Korea

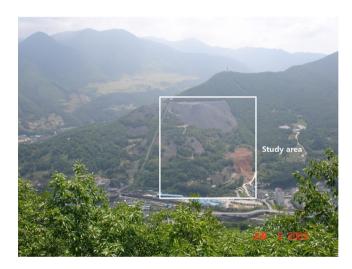
Fig. 2. Panoramic view of the study area.

Fig. 2 shows an aerial view of the study site and shows the coal waste dump built on the ridge of the natural slope. As shown in Fig. 1, many houses and various parts of the social infrastructure of the area, including roads and railroads, are located under the coal waste dump at Dogye village. Therefore, a slope failure at the waste dump would most likely cause significant losses of life and property.
