# Assessment of structurally-controlled slope failure mechanisms and remedial design considerations at a feldspar open pit mine, Western Turkey

Hakan Tanyas<sup>a</sup>, Resat Ulusay<sup>b,\*</sup>

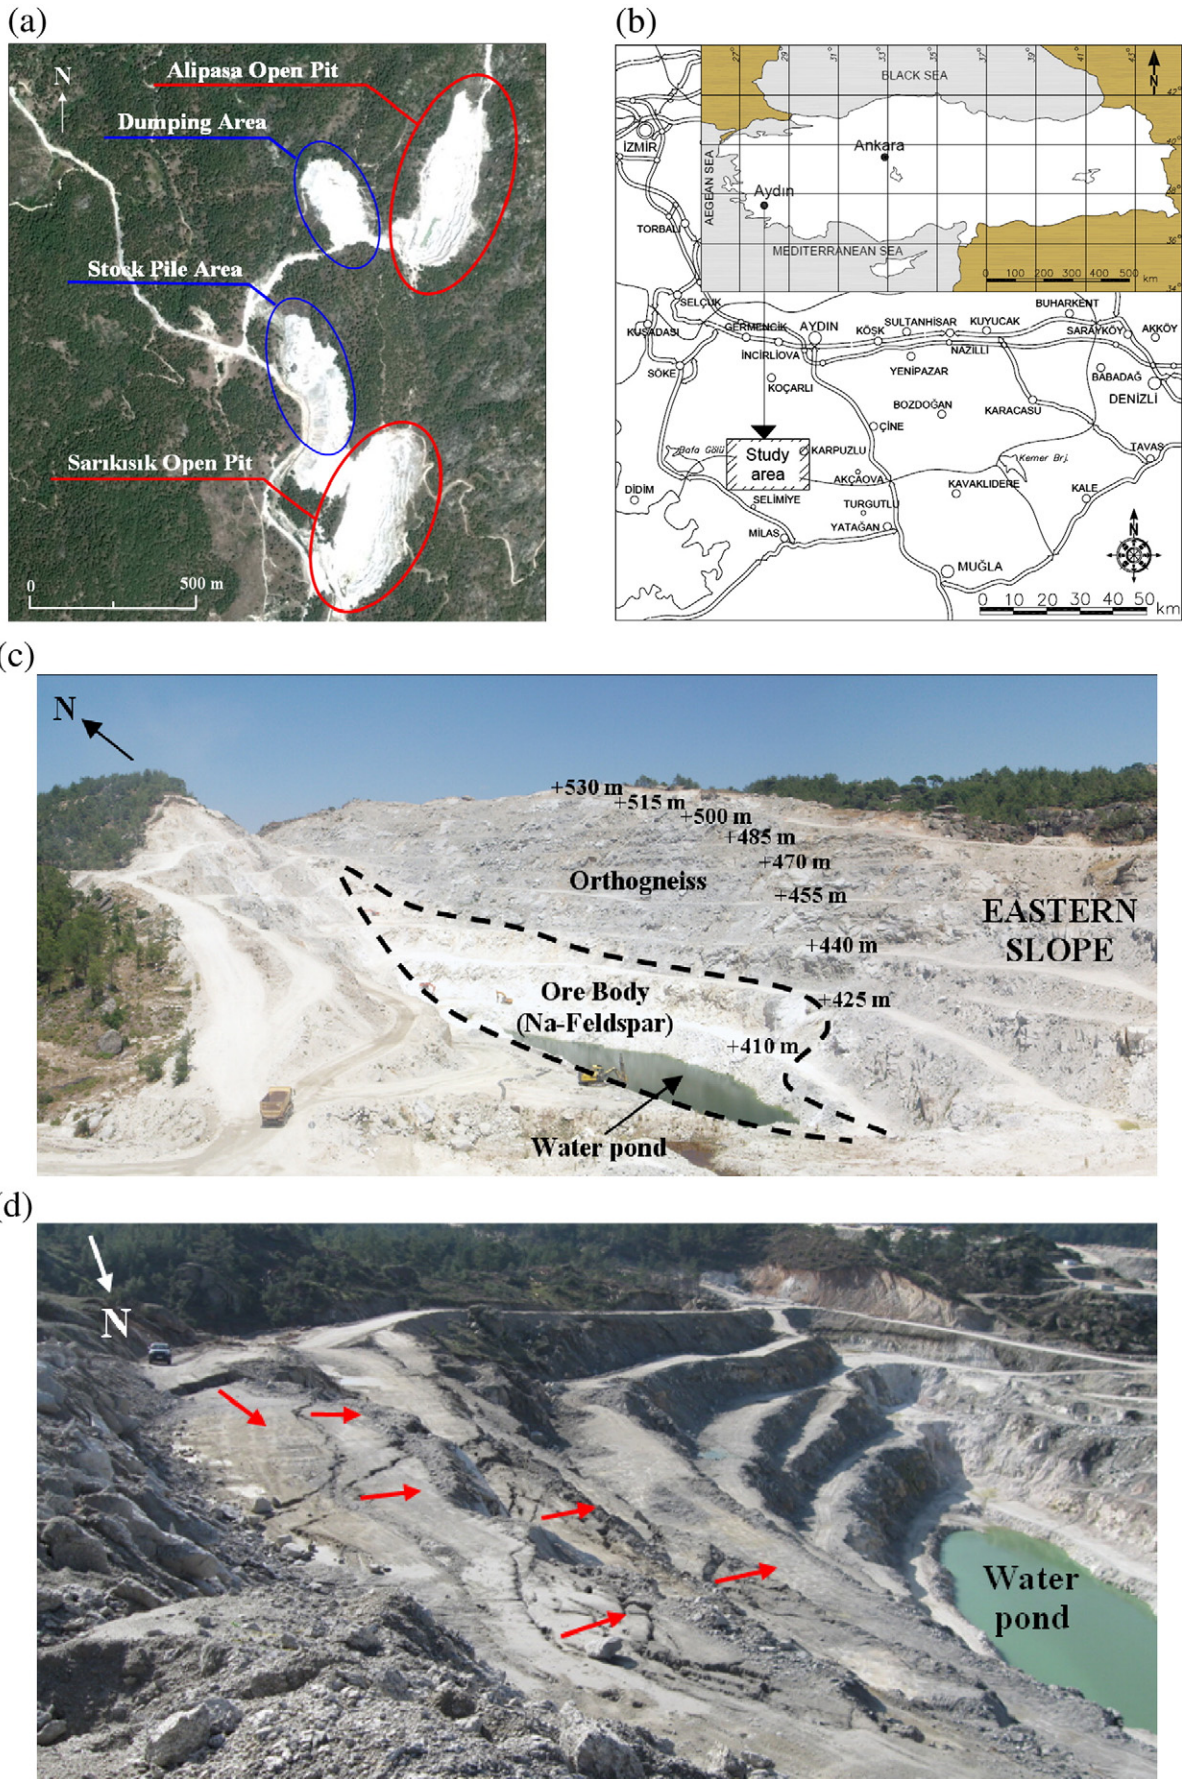
The instabilities were experienced in the eastern slope of the pit in August 2008 after a rainy spring season. A number of highly persistent tension cracks propagated and planar and wedge failures occurred in some benches (Figure 1d). Preliminary observations performed by Ulusay (2009) called for a detailed geo-engineering investigation.

Fig. 1. (a) Satellite view of the Alipaşa feldspar open pit and its surroundings ([www.maps.google.ca](http://www.maps.google.ca)), (b) location map of the study site, (c) a view from the Alipaşa pit, (d) view from some structurally-controlled bench instabilities occurred at the eastern slope.
