Case Studies in Nondestructive Testing and Evaluation

Eddy current analysis of shipped stainless steel heat exchanger bundle

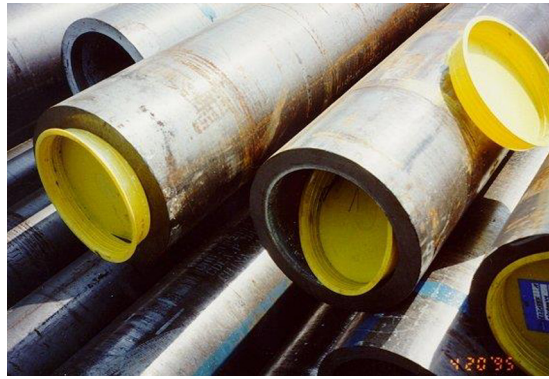
It is common practice for all tubes manufactures to protect both tubes end with plastic caps to prevent the ingress of water and other materials, which can cause damage to the internal tube surface [1], as shown in Fig. 1 below.

Fig. 1. Plastic caps cover at the end of the tube prior to shipment.
