Assessing power degradation and reliability of crystalline silicon solar modules with snail trails

Hong Yang^a, Wenshuang He^a, He Wang^{a,*}, Jingsheng Huang^b, Junjun Zhang^b

ABSTRACT

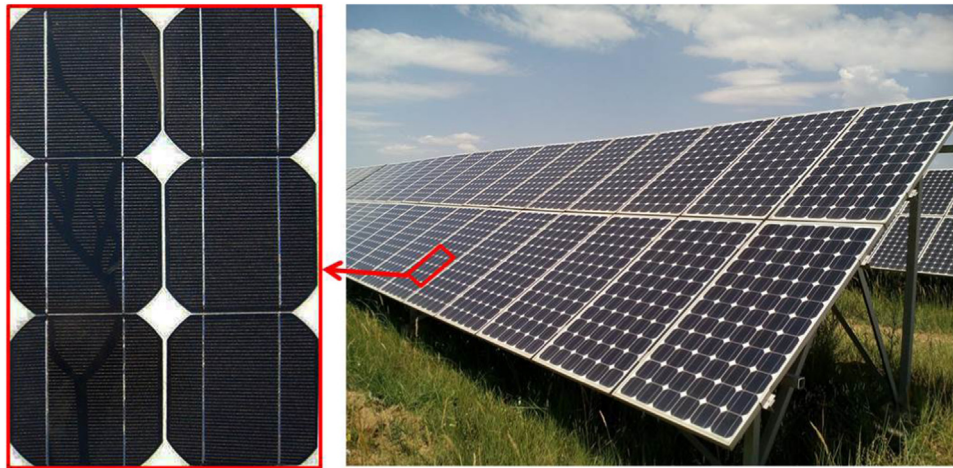
Fig. 1. Photovoltaic power plant with snail trails.

The experimental solar modules were dismantled from the photovoltaic power plant, as shown in Fig. 1. This photovoltaic power plant was connected to the grid in October 2010 with the installed capacity of 2 MWp. The peak power of the solar modules used in this power plant is 185Wp, which has a tolerance from 0 to +5%. The solar modules were encapsulated with the same materials, which consists of a glass superstrate, crystalline silicon solar cells, different polymer layers and tinned copper ribbons. The backside of the module is a white TPT (Tedlar/ Polyester/Tedlar). In September 2011, the four solar modules with snail trails and four solar modules without snail trails, which dismantled from the power plant, were installed on the roof of the laboratory building for tracking study. These solar modules were marked S1, S2, S3, S4 (modules with snail trails), and N5, N6, N7, N8 (modules without snail trails) in sequence.
