Forensic Science International

Case Report

Visual and oxide analysis for identification of electrical fire scene

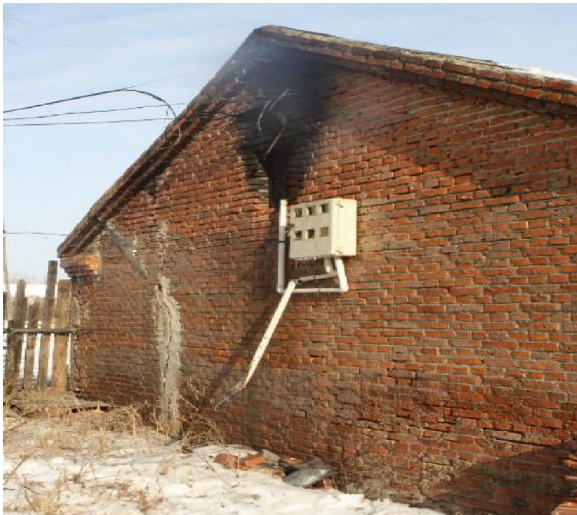
The examined countryside house fire occurred at 4 am on January 15th, 2015 in Mudanjiang, China. The fire report from fire personnel and witnesses pinpointed the fire started at the distribution board outside the building and quickly engulfed the structure. The fire caused neither dead nor wounded but damaged property at an estimated loss of ¥800,000. Fig. 1 shows the damaged building after the fire. The distribution board outside the building was damaged significantly. Three wires leading to different households named No. 1, No. 2 and No. 3, respectively, were found in the fire scene. Fig. 2 shows the electrical wires with and without bead that were found leading to the distribution

Fig. 1. The rare brick-concrete composite structure houses after the fire. The distribution board and electric meter box were outside the building and damaged in the fire.

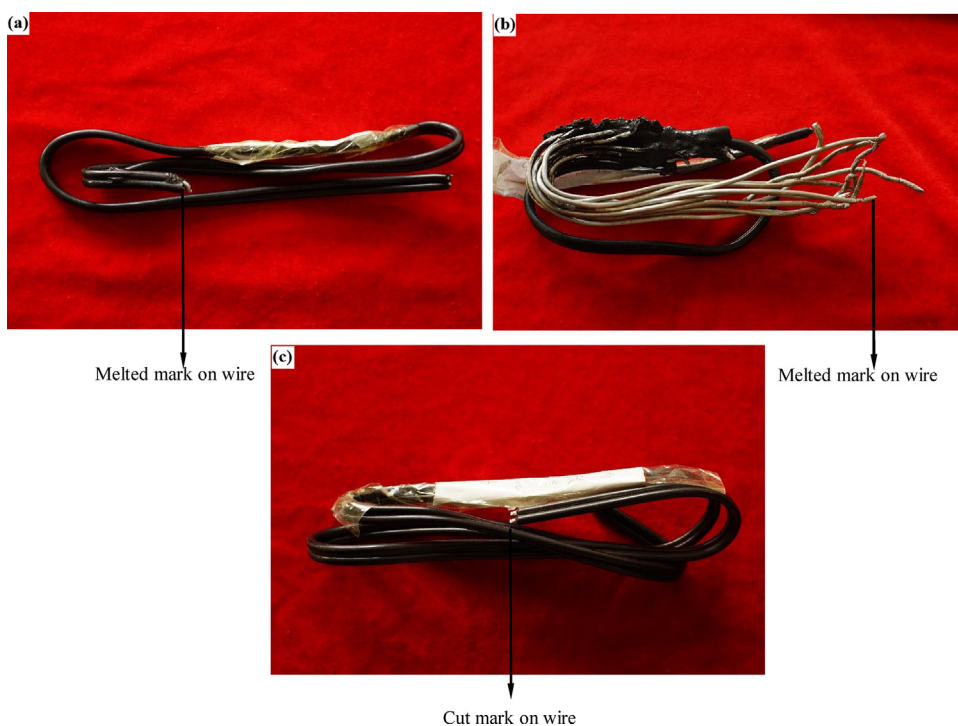
The fire damaged and undamaged wires near the contact of the burned distribution board were cut into specimens and are shown in Fig. 2. From the macroscopic observation on No.1 wire as shown

in Fig. 2a, it can be seen that the wire was fused, only a small area was affected by heat and the outside sheath was only slightly hardened except pyrolyzation close to the melting point. For No. 2 wire shown in Fig. 2b, it is apparent that the metallic wire was fused and the length of wire heated was much longer than that of No. 1 wire. Additionally, the No. 2 aluminum wire was covered by an oxide scale that is readily cracked and spalled into large flakes (friable to the touch). The insulating polymer layer was completely decomposed around melting point and the left was curled and charred. Fig. 3 shows the melted mark at the ends of No. 1 and No. 2 wires. The No. 3 wire is undamaged, and shown as a comparison.

Fig. 2. View of wire with and without melted mark at the end (arrow indicates), (a) No. 1, (b) No. 2 and (c) No. 3, the melted mark was used for further metallographic examinations.
