Assessment of a cracked reinforced concrete beam: Case study

This paper presents the analysis and repair of a cracked reinforced concrete beam in a 3-story office building in Riyadh, KSA during its construction and near completion. In October 2015, a reinforced concrete beam with a cross section of 300 mm x 1500 mm and a clear span of 16.5 m in this building cracked at the connection with one of its supporting columns. This crack propagated on both sides of the beam. To investigate the main reason of the beam cracking, a site visit was conducted to visually inspect the cracking beam and the connecting structural elements. After that a detailed analysis of the beam using PLAXIS and SAP2000 to investigate the stresses developed in the beam, spot the most stressed parts and to check the adequacy of the design. The analysis revealed the inadequacy of flexural resistance of the beam as well as the shear and torsion capacity. The main reason of the crack is underestimating the cladding weight. Based on the results, a repair methodology was selected using CFRP sheets to increase the flexural capacity of the beam section with enhancement to its torsional and shear carrying capacity to mee

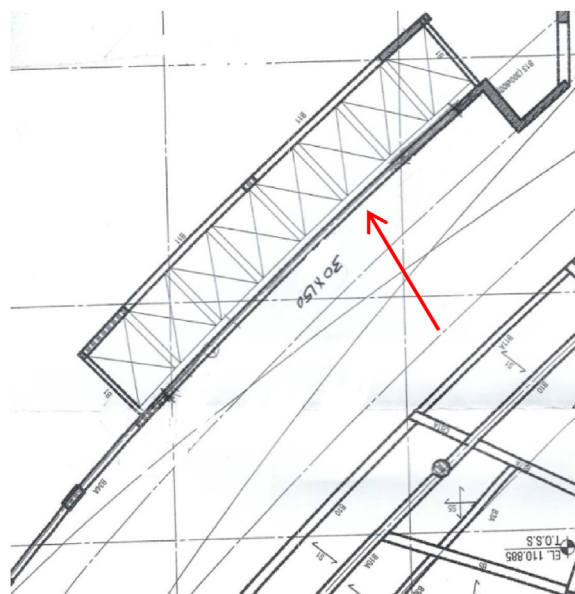
Fig. 1. The cracked beam location on the floor layout.

A crack of more than 10 mm width was detected in an edge reinforced concrete beam of the second floor of a three-story office building in Riyadh. This beam has a clear span of 16.5 m with a section of 300 mm x 1500 mm. A plan showing this beam is presented in Fig. 1, and the beam reinforcement is presented in Fig. 2. It was reported that the crack was first noticed after erection of the heavy, exterior cladding on the inflected beam. The crack is located at the beam-column joint. The adjacent beam cross section is 400 mm width and 700 mm height with a span of 4.0 m.
