Research Paper

Numerical investigation into the failure of a micropile retaining wall

The paper presents a numerical investigation on the failure of a micropile wall that collapsed while excavating the adjacent ground. The main objectives are: to estimate the strength parameters of the ground; to perform a sensitivity analysis on the back slope height and to obtain the shape and position of the failure surface. Because of uncertainty of the original strength parameters, a simplified backanalysis using a range of cohesion/friction pairs has been used to estimate the most realistic strength parameters. The analysis shows that failure occurred because overestimation of strength and underestimation of loads.

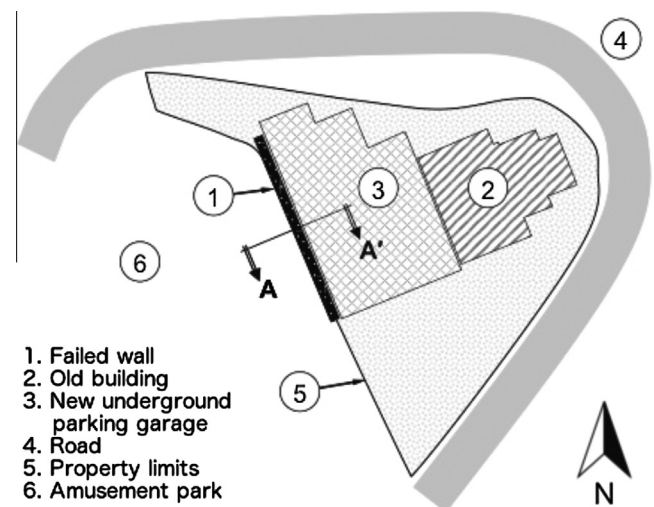
The location where the failure occurred is a hill near Barcelona, Spain. It has an irregular rounded triangular shape (Fig. 2), with a total surface area of approximately 6000 m². The topography is determined by its location near the top of a hill which is at the SE end of the coastal range that runs approximately parallel to the coast and is formed by a sequence of low-height ranges. The lithology units outcropping in the range are the oldest in the area, consisting mainly of meta-sedimentary Palaeozoic rocks, especially

Fig. 2. Sketch of the area showing the original position of the collapsed wall. Section AA' is shown in Fig. 5.
