Expansions with different origins in a concrete dam with bridge over spillway

A. Blanco^{a,*}, S.H.P. Cavalaro^a, I. Segura^{b,c}, L. Segura-Castillo^d, A. Aguado^b

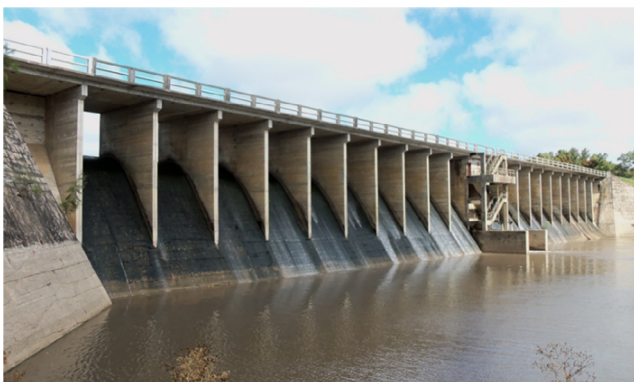
Fig. 1. General view of the concrete dam and the bridge over the spillway.
