Construction and Building Materials

Pre-diagnostic prompt investigation and static monitoring of a historic bell-tower

Antonella Saisi*, Carmelo Gentile, Antonello Ruccolo

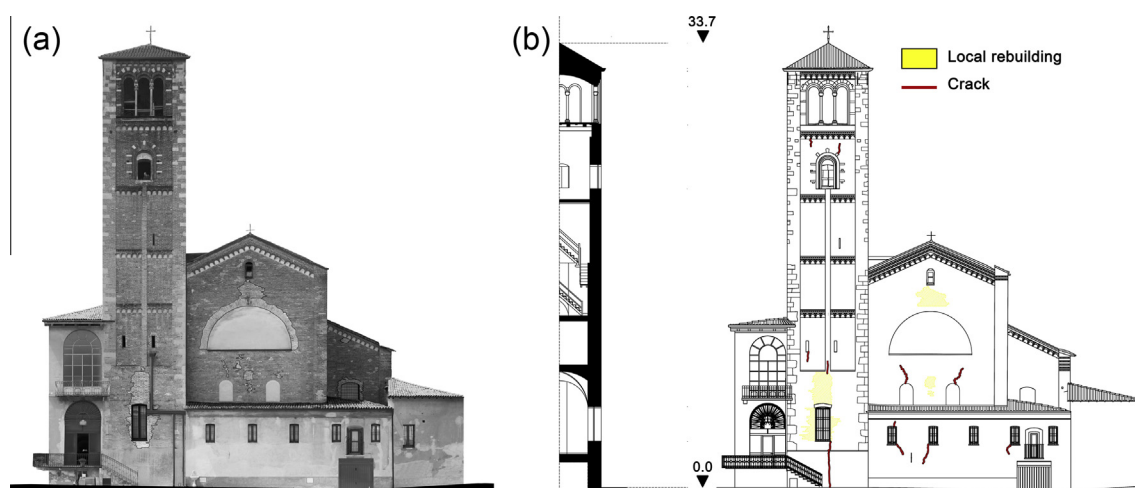
East side of the tower conceivably activated movement of the pre-existing cracks and of the structural discontinuities related to construction phases.

Fig. 1. The Church of *Santa Maria del Carrobiolo* and the bell-tower: (a) Orthoplane; (b) Geometric survey of the East front of the tower and the church apse (cracks and local rebuilding are mapped, dimensions in m).
