Investigation of discrepancy between tuff used as building stones in historical and modern buildings in western Turkey

Ali B. Yavuz^{a,*}, Cüneyt Akal^a, Necdet Türk^a, Mümtaz Çolak^a, Burak F. Tanyu^b

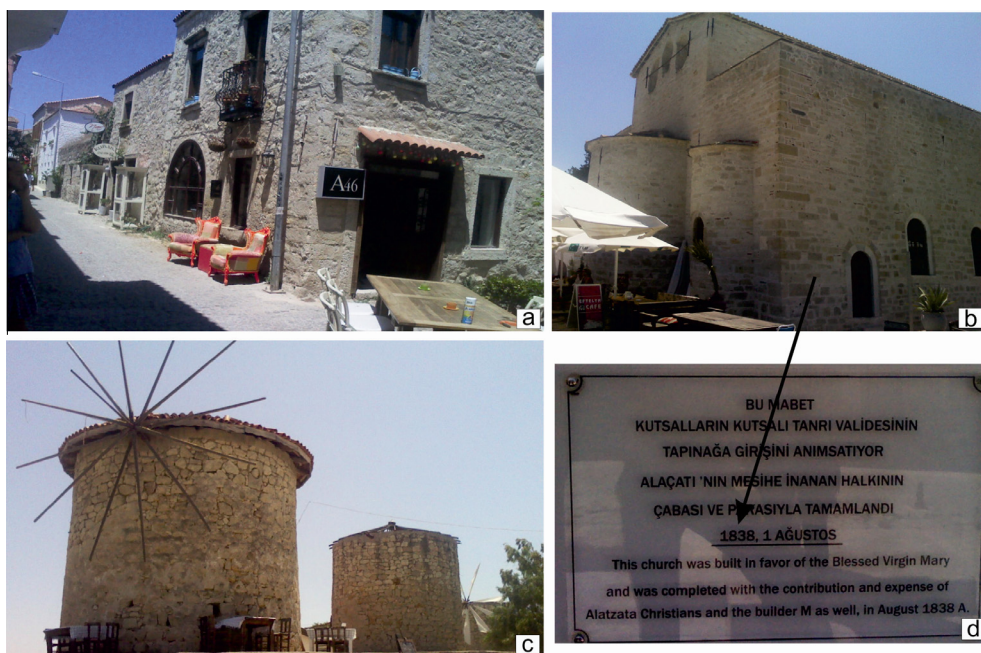
seen intact in parts of Alaçatı. Beside the old houses, the town has an old church constructed primarily using building stones from tuff in 1838 and three wind mills built more than 100 years ago (Fig. 1).

Fig. 1. Examples of historical buildings constructed in Alaçatı with tuff: (a) historical house, (b and d) historical church that was built in 1838; and (c) abandoned historical wind mills.
