Nonlinear finite element analyses for the restoration study of Xana, Greece

Vasiliki G. Terzi*, Christos E. Ignatakis

Department of Civil Engineering, Aristotle University of Thessaloniki, 54 124 Thessaloniki, Greece

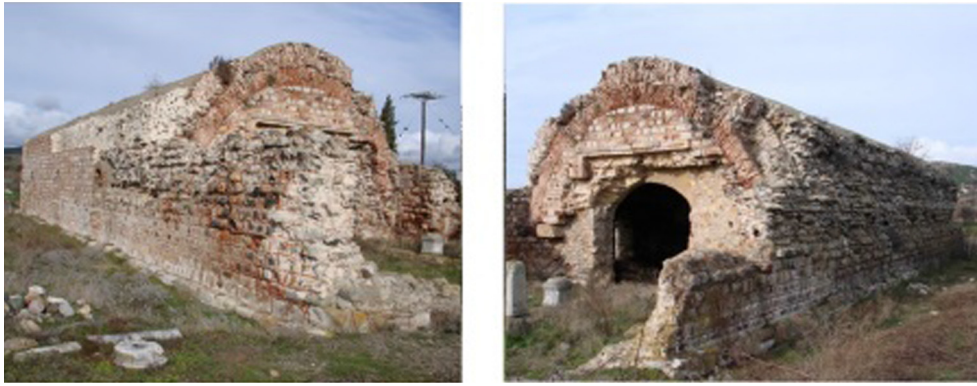
Fig. 1a. Xana, present state (S-W and S-E illustration).

The identification and the monitoring of the pathology condition of the structure in combination to the knowledge of the actual cracking path, plays an important role in understanding the current state and behavior of the structure as well as in selecting the suitable restoration methods [11,16,27,28]. Therefore, Xana's pathology was thoroughly investigated. One of the main problems is a vertical fracture on the northern wall, which is attributed to soil subsidence due to the combination of clay soil foundation and high water level (thermal baths). Another important aspect is the tensile cracks running along the interior surface of roof and in the vertical direction as well, where the openings are situated. The cracks can be attributed to the action of the large self-weight of the roof in combination with the absence of horizontal tendons. Hair cracks, loss of stone material, detachment of small pieces, exfoliation, mortar pulverization, efflorescence and blistering can be attributed to the action of marine aerosols [29,30], taking into account that the monument is located only 6 km from the Aegean sea; to biological colonization; to drainage problems [30] in combination to unsuitable repair materials, such as cement [31] and to soil moisture.
