Dynamic response of a damaged masonry rail viaduct: Measurement and interpretation

Sinan Acikgoz^{d,*}, Matthew J. DeJong^b, Cedric Kechavarzi^a, Kenichi Soga^c

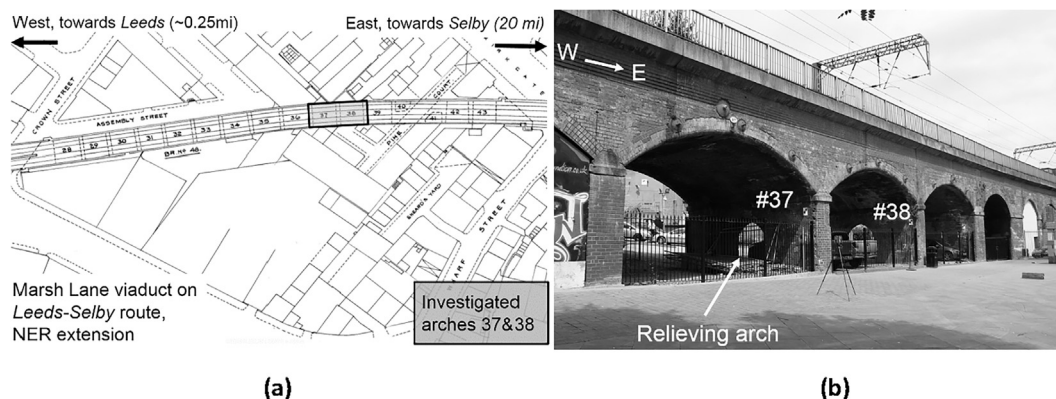
Marsh Lane viaduct is a masonry viaduct on the Leeds-Selby route (see Fig. 1a). The investigated section, which comprises of Arches 37 and 38, was constructed during the North Eastern Railway Leeds Extension between 1865 and 1869 [22]. The bridge carries two electrified tracks, and has a speed limit of 35 mph.

Fig. 1. (Left) Plan view drawing of a section of the Marsh Lane viaduct (British Railways drawing 73-YWR-513) and (Right) a photo showing the southern side view of the investigated arches 37 and 38.
