Long-term monitoring of a damaged historic structure using a wireless sensor network

The present work contributes for the SHM implementation through the strategy description, and monitoring of the Foz Côa Church (Portugal). Moreover, this work reports the monitoring period between March 13th 2015 to March 29th 2016 and discuss the relative displacements and tilt records in some structural elements of the church, as well analyses the environmental influence on the displacements collected by the wireless sensor network.

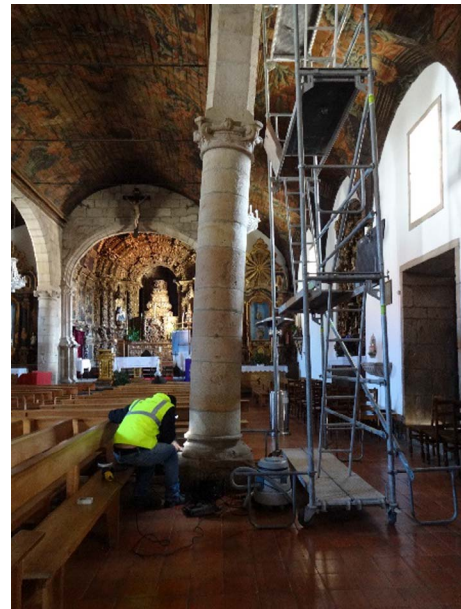
Fig. 2. Photograph of column 2, evidencing its inclination.

The church presents some damages, essentially cracks and deformation along the structural elements. The walls and columns on the right side are significantly deformed, especially the columns, as can be observed in the details in Fig. 2, whereas some vertical cracks on the main façade can be observed, as demonstrated in Fig. 3. Fundamentally, the main deformations and cracks are related with two seismic occurrences, namely the earthquakes of 1755 and 1969, being the first one related with the deformation of the structural elements inside of the church, specifically on columns and arches, while the last seismic occurrence has been pointed as the responsible by the emergence of cracks in the main façade (Fig. 3).
