Progressive collapse evaluation of Murrah Federal Building following sudden loss of column G20

Ali Kazemi-Moghaddam^a, Mehrdad Sasani^{b,*}

ABSTRACT

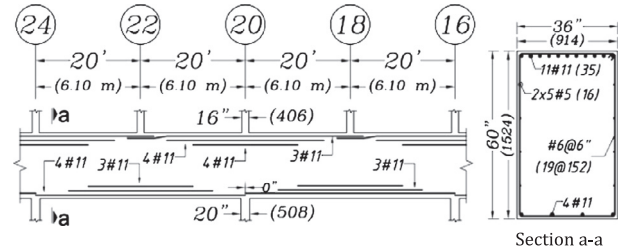
Fig. 3. Longitudinal profile of TG reinforcement, NTS (numbers in parenthesis are in m or mm).

The structural system of the 3rd floor included a TG in the longitudinal direction (E–W) at the north face of the building. The TG section was 36" wide and 60" deep (914 by 1524 mm). Fig. 3 shows a longitudinal profile of the middle portion and one cross-section of the TG reinforcement. As can be seen, the bottom bars of the TG were not continuous over the top of the main columns (i.e. the splice length was zero). Therefore, the #11 (36 mm) bottom bars were embedded by only 10" (254 mm) into the joint (7d_b).

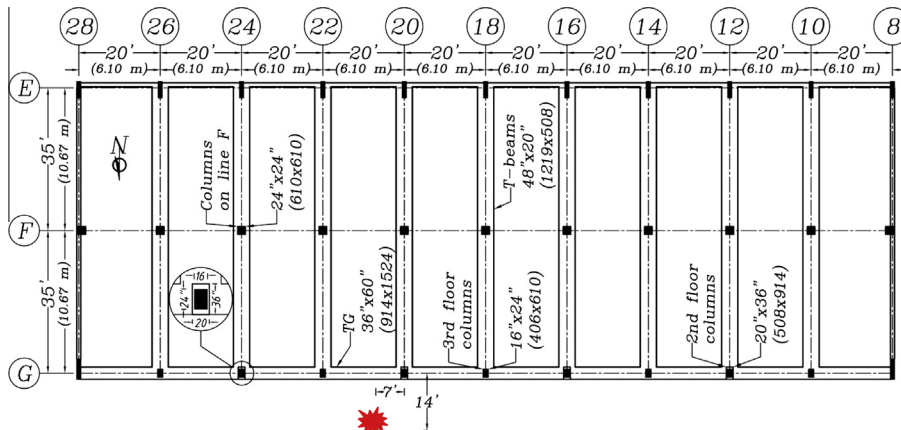
Fig. 2. Plan view of 3rd floor (numbers in parenthesis are in m or mm).

Columns below and above the 3rd floor on line G were spaced 40' and 20' (12.19 m and 6.10 m), respectively. The 3rd floor columns on lines 10, 14, 18, 22, and 26 were supported by the TG and were not continuous to the ground (see also Fig. 19 for column configuration). The typical story height was 13' (3.96 m) and the height of the 9th story was 14' (4.27 m). The cross sections of the 1st and 2nd floor columns on line G were 20" by 36" (508 by 914 mm) and those of the columns above the 3rd floor were 16" by 24" (406 by 610 mm). Fig. 4 shows the cross sections of the columns on line G. The columns on line F were 24" by 24" (610 by 610 mm) up to the 4th floor and 20" by 20" (508 by 508 mm) above it. The locations of the 3rd floor columns on line G, in the transverse direction (N–S), were not clearly mentioned in the available documents [4,5], and also could not be inferred from the drawings. In this study, considering the space required for the façade system and a photo of the building after collapse, it is assumed that the center of the 3rd floor columns on line G, the center of the 2nd floor columns on line G, and the center of TG were vertically aligned (see zoom-in detail in Fig. 2).
