Case study and design of steel set support for aged belt entry rehabilitation

Kevin Jinrong Ma^{*}, John Stankus

Keystone Mining Services, LLC, Pittsburgh 15106, USA

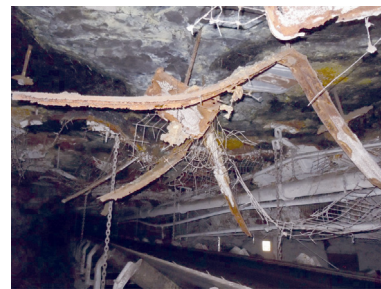
In aged belt entries, metallic roof support systems, such as bolts, cables, plates, roof channels, wire mesh, and roof pans, are likely to corrode and rust away due to exposure of moisture and air over time. Fig. 3 shows typical rusted roof support systems in a belt entry. The metallic roof support systems have corroded and degraded so that ground support no longer exists. Furthermore,

Fig. 3. Corroded mesh, channels, and roof bolts.

broken roof channel and related hardware hang over the running belt structure, posing an immediate hazard to the conveyor belt and to personnel if they fall off the roof.

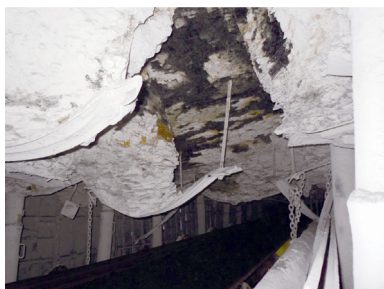
Fig. 1 shows a deteriorated immediate roof condition in an aged belt entry. Such a condition is generally associated with thin, weak, laminated roof strata that is weathered and deteriorated due to long-term exposure to moisture and air, lack of adequate surface control, and insufficient roof support. In this case, the roof beam initially built by the primary support is completely compromised.

Fig. 1. Laminated roof.

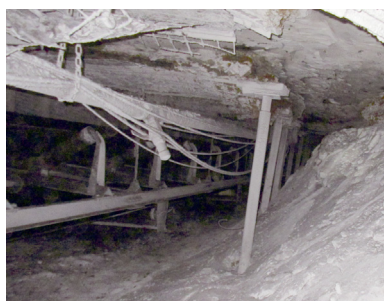
In some cases, portions of coal ribs fracture, yield, and collapse over time due to concentrated stress on the pillars and a lack of proper rib support. In many cases, pillar sloughage occupies walkway space, and operators usually remove loose material off the rib and floor for an easier walkway for mine personnel. However, this action removes lateral confinement from the coal rib and results in additional rib sloughage. Consequently, effective pillar size reduces, and roof span at the area increases. Fig. 2 shows a belt entry that has severe pillar sloughage and increased roof span.

Fig. 2. Pillar sloughage and extended roof span.

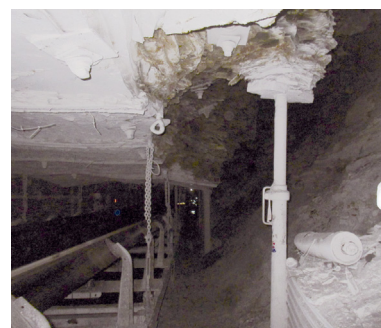
Fig. 4 shows a typical gutter roof failure. In this case, the gutter roof failure was about 13.7 m long, 3.7 m upward from roof line, and 2.4 m into and above the pillar. From a ground control perspective, this condition is particularly dangerous and should be addressed in a timely manner.

Fig. 4. Cutter roof failure.
