Damages on reinforced concrete buildings due to consecutive earthquakes in Van

Sevket Ates^{a,*}, Volkan Kahya^a, Muhammet Yurdakul^b, Suleyman Adanur^a

ABSTRACT

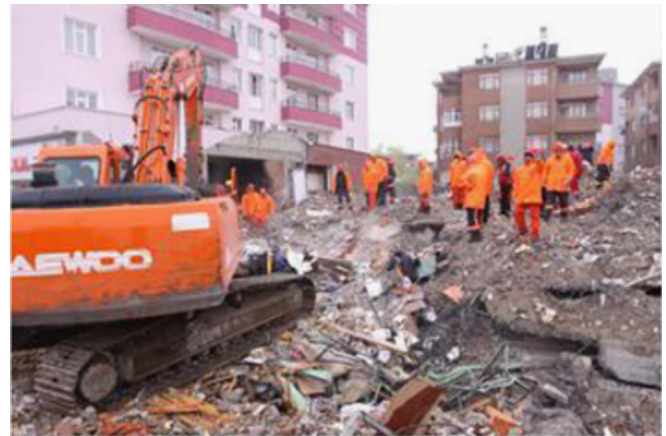
Fig. 3. Rescue teams made every endeavor to save victims from the rubbles.
