Analysis of longitudinal skylights structure made of rectangular tubes in industrial hall

Bronisław Gosowski*, Paweł Lorkowski, Michał Redeki

Wrocław University of Science and Technology, Faculty of Civil Engineering, Wybrzeże Wyspiańskiego 27, 50–370 Wrocław, Poland

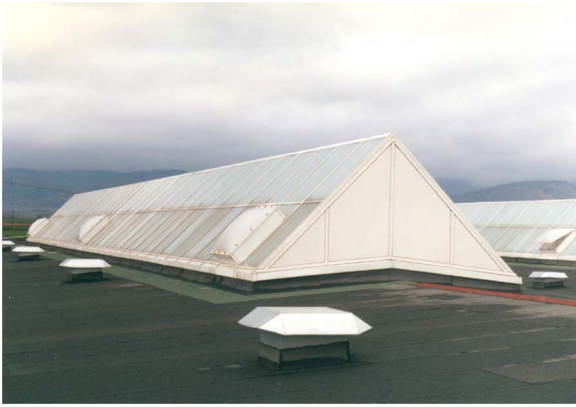
Many of the wired glass panes in the skylights of the considered industrial hall became cracked (Fig. 1). The cracks ran vertically (Fig. 2a) or obliquely (Fig. 2b) and were caused by the excessive mutual displacement of the skylights' structural members, i.e. the frames and the longitudinal girts. The faulty design of the joints between the tubular elements, made as erection bolted joints, contributed to the displacements. Neither the interaction with the roof structure nor the compliance in the joints between the tubular elements had been taken into account in the computational model.

Fig. 1. Long skylights in industrial hall bay A–B between transverse systems 2–6.

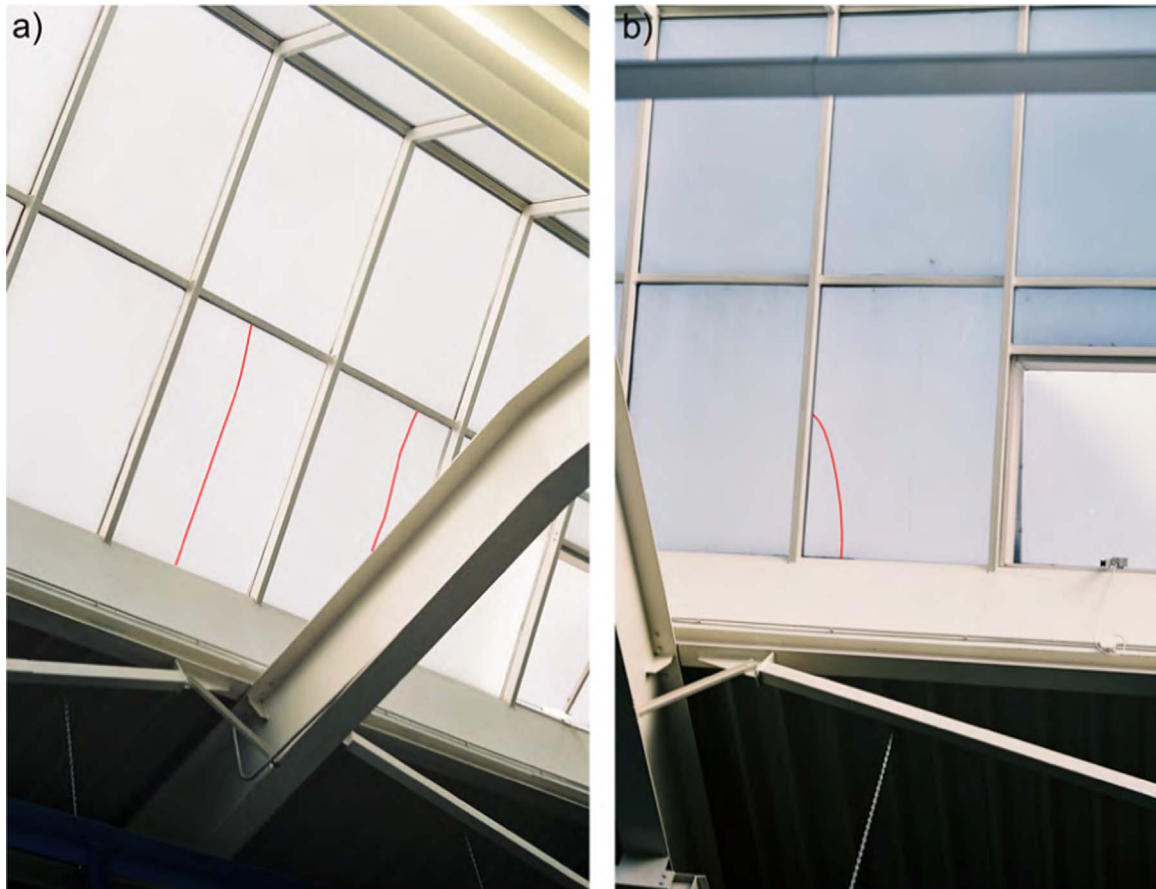
Fig. 2. Cracks in skylight panes: (a) vertical, (b) oblique.
