An analysis of starburst defects in wrinkled powder coatings

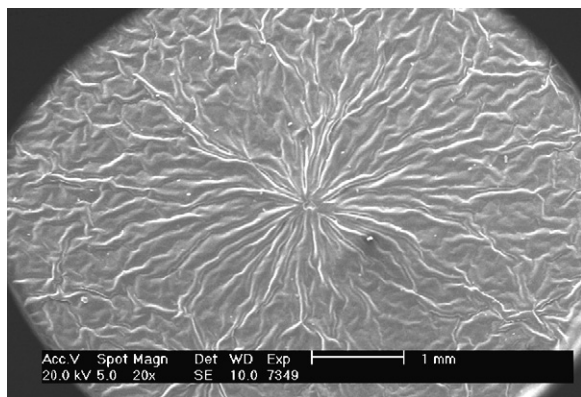
Fig. 1. SEM micrograph of a starburst defect.

The starburst phenomenon can be described as a radial convergence of the wrinkle patterns with a well-defined center (see

Fig. 1). The stars have a radially symmetric order compared to the rest of the coatings area where patterns are oriented randomly. Fig. 2 presents both 2D and 3D mechanical profilometry traces of typical starburst defects obtained from Samples 2 and 4. Fig. 2 also presents color coded topographical measurements of the stars. From the mechanical profilometry traces and topographical measurements, it is evident that the center of the star is at a higher elevation than its surroundings. The higher elevation of the center was observed for all the stars investigated in all five samples. Based on these observations, it was hypothesized that unmelted powder particles, extender or external impurity present at the center of the star is responsible for the formation of the starburst defects.
