Failure analysis on recovering low resistive via in mixed-mode device

M. Castignolles *, J. Goxe, R. Martin

Freescale Semiconducteurs France SAS, Toulouse Product Analysis Laboratory, France

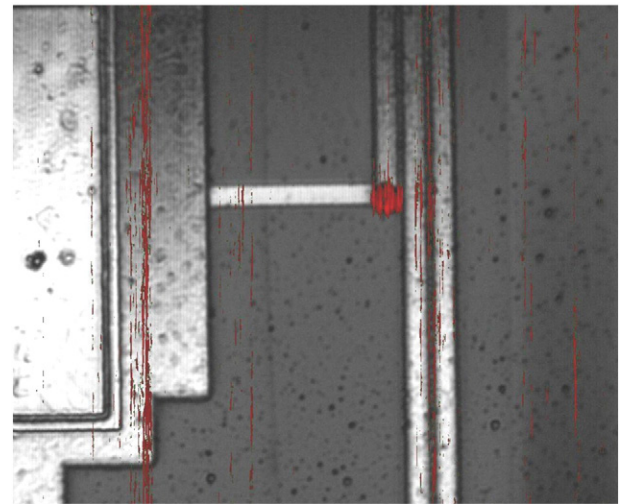
Abnormal laser sensitivity was observed at a via1 location, indicating the resistive defect location close to TC2 pad (Fig. 2). During the OBIRCh analysis the part partially recovered: the value of the resistive defect decreased.

Fig. 2. OBIRCh image highlighting the defective via.
