Microelectronics Reliability

Latent gate oxide defects case studies

J. Goxe *, C. Abouda, B. Vanhuffel

Freescale Semiconducteurs France SAS, Toulouse, France

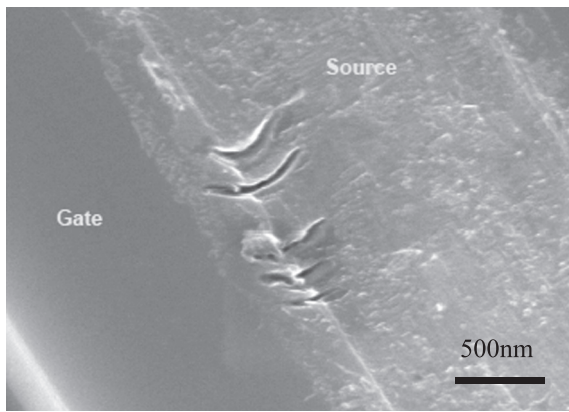
Different physical analysis approaches can be used to characterize micro-scratch defects. The first consists of deprocessing the die straight down to Silicon level by using hydro fluoric acid (HF). This technique applied to a defective part returned by customer allowed to highlight several similar silicon scratches in active area in the shape of “shark gills” as illustrated in Fig. 1. This defect was evidenced using Optical Beam Induced Resistance Change (OBIRCh) technique [1] which

pinpointed an abnormal resistance change inside the leaky MLDO MOS transistor. The presence of these anomalies at Silicon level has weakened gate oxide layer and induced its rupture at customer level.

Fig. 1. SEM picture: Silicon "shark gill" microscratches.

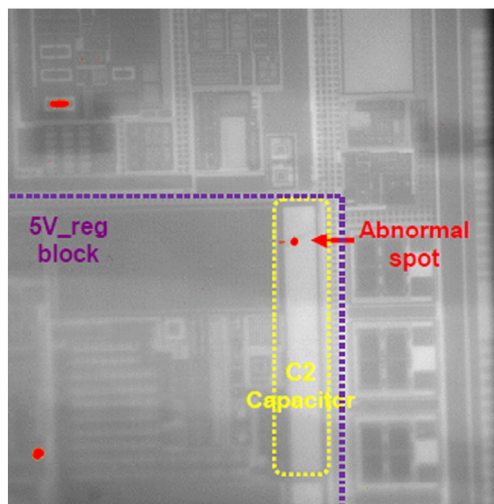
The second physical approach performed with Focused Ion Beam (FIB) cross section on field customer return allowed a clear understanding of the origin of the wafer fab issue. This part presented a functional failure (wrong voltage on VCC5) and was analyzed by Emission Microscopy (EMMI) technique [2] to localize a defective area on C2 capacitor (short failure) (see Fig. 2). FIB cross-section at this location evidenced a Wafer Fab issue in the Shallow Trench Isolation (STI): STI scratches (see Fig. 3) [3]. This defect explained the capacitor short failure.

Fig. 2. Backside EMMI localization on C2 Capacitor.

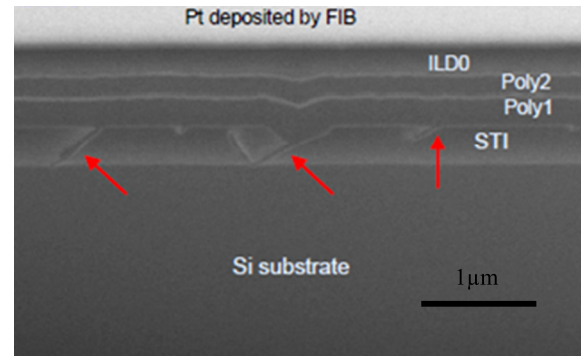
In summary, improper STI polish step is responsible of micro-scratch:

- First case showed micro-scratch at silicon active area
- In second case STI scratch are directly responsible of this defect.

Fig. 3. FIB cross section: STI micro_scratches.

Two correctives actions were implemented:

- 1) Improve polish pad conditioner cleaning by converting spray nozzles to lower flow with higher velocity, which reduces probability of fall-on particle to the polish pads.
- 2) Implement global irrigation flow control which reduces splash-back of debris onto the polish pads.

Wafer fab evaluation data showed 50% particle reduction with the CMP improvements compared to the current process. Such improvements cannot guarantee zero defect but they contribute efficiently to reduce the defect recurrence. These CMP improvements have been implemented on applicable tool sets.

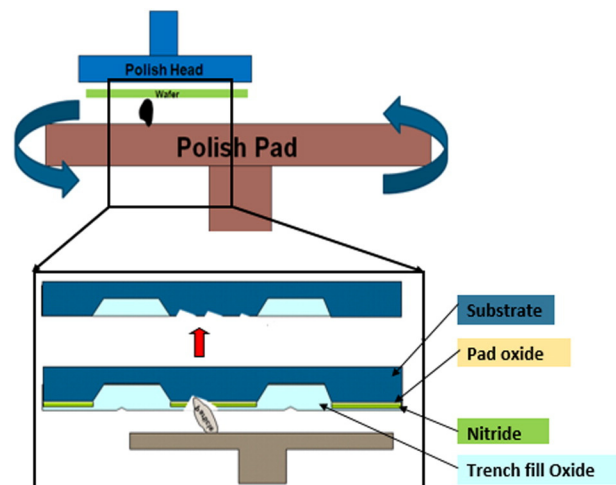
For micro scratch defect, investigations showed that the process step responsible for these STI and active area scratches is correlated to particle defectivity during Chemical Mechanical Polishing (CMP) process [4]. On CMP Tool during STI polish process, polish pad spins and polish head will lower the wafer (with top surface facing down) towards the pad to be polished. The process is accomplished by polishing slurry consisting of colloidal silica suspended in a KOH solution. Once packed into the polish pad, the silica particles agglomerate and then scratch the surface of the wafer causing damage (see Fig. 4). Consequently, by reducing

particle defects in the CMP process, the probability of micro scratch defectivity will be reduced.

Fig. 4. Microscratch defect formation principle.
