A study on electrochemical effects in external capacitor packages

H. Preu^{*}, J. Feilmeier, M. Lang, N. Soellner, J. Walter, W. Mack

Infineon Technologies AG, Regensburg, Germany

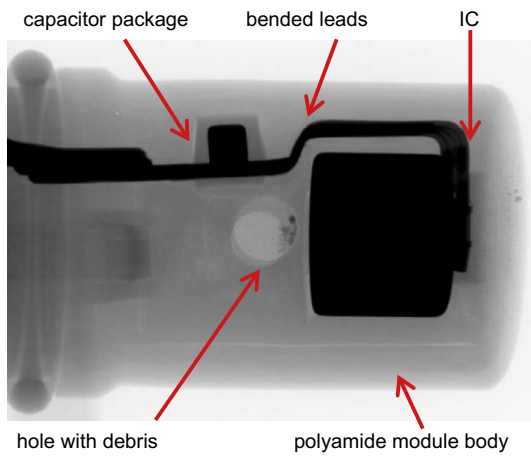
Fig. 1 shows a module with bended leads and the contact to the module wires (left hand side) after the overmold process. The ceramic capacitor is attached to the leads by silver epoxy glue and protected with an electronic molding compound (=EMC). A gap between EMC and overmold material is visible directly at the tip of the red arrow. Debris is visible in the support hole.

Fig. 1. X-ray-microscopy image of a module after overmolding.

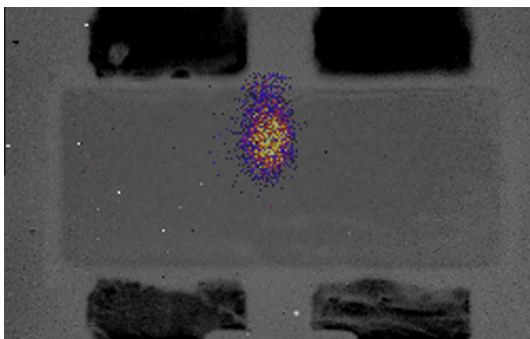
The infrared lock-in thermography (IRLIT) analysis of a package in a different analytical case showed a hot spot at the capacitor position (Fig. 2). Therefore the expectation was that Ag-dendrites at the interface between ceramic capacitor and molding compound are the reason for the electrical failure. After X-ray analysis which did not show any remarkable deviation, the sample has been cracked mechanically to avoid any contamination by sawing (Fig. 3).

Fig. 2. IRLIT image of a capacitor package.

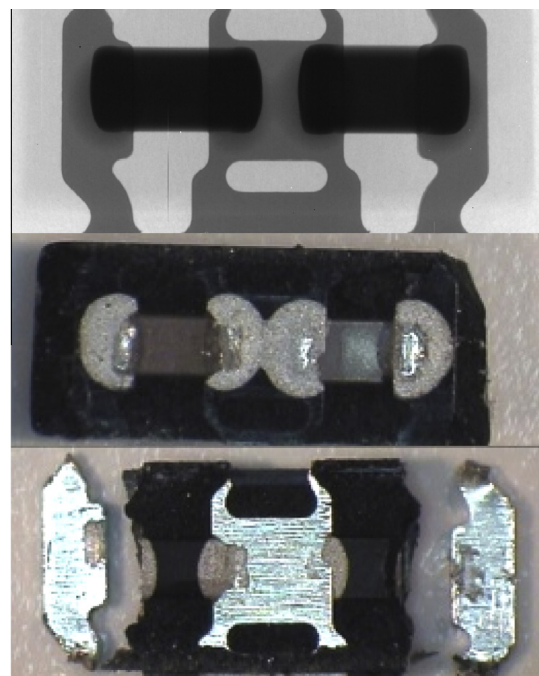
Fig. 3. X-ray-microscopy image and optical image of the capacitor package after cracking.
