# Lessons learned from analyzing a VCE accident at a chemical plant

On June 5, 2017, there was a Vapor Cloud Explosion (VCE) at JinYu Petrochemical Co. Ltd. During unloading of liquefied natural gas, the gas leaked from the truck and formed a vapor cloud, then the vapor cloud met with the electrical sparks in the plant laboratory, and an explosion occurred. This incident caused significant casualties and property loss. The main causes of the accident are demonstrated by a fishbone diagram. The major causes include (a) defective design, (b) noncompliance with standard operation procedures (SOPs), (c) the presence of ignition sources, (d) ineffective enforcement of safety rules, (e) inadequate design of emergency facilities, and (f) delayed emergency response. The analysis reveals that process safety management (PSM) is a crucial factor in the success of chemical plants, especially for small and median-scale companies in developing countries. Dispersion phenomenon of liquefied gas is simulated by commercial Computational Fluid Dynamic (CFD) software. The simulation results approximately agree with the real incident. The simulation indicates that a visual and quantitative consequence

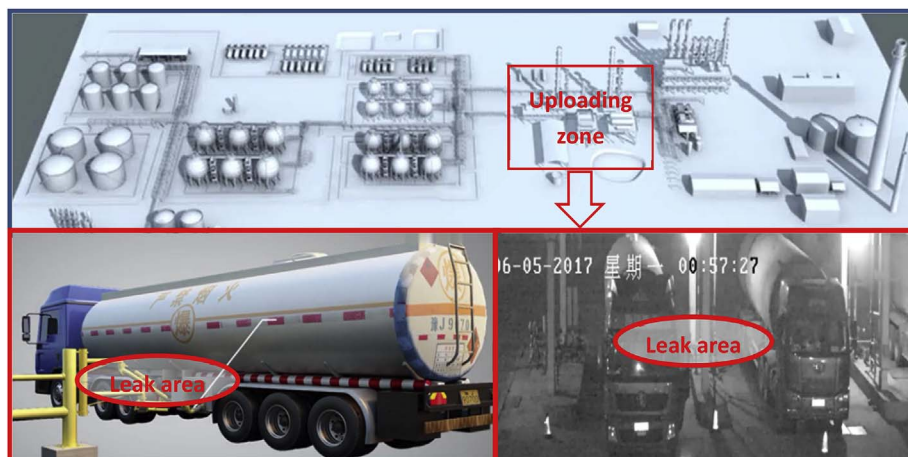
Fig. 2. The leakage location of the loading/unloading zone.

In the early morning of June 5, a tanker truck arrived at the unloading zone. The driver got out of the truck and tried to connect the omnidirectional loading arm to the tanker's discharge outlet. However, he failed to connect the arm to the outlet properly. Suddenly, large amount of liquefied gases began to leak. And the gases quickly spread over the unloading zone. The location of leakage is shown in Fig. 2.

operating procedures and without supervision, the driver failed to connect them properly. The worker on duty carelessly checked the spot and did not find out any problem. A leakage of liquefied gas began. After a period of 130 s following the release, a cloud of liquefied gas was ignited. A vapor cloud explosion occurred due to an ignition source in the laboratory to the north. As a result, serious damage occurred through a domino effect. Table 1 summarizes the timeline of this incident.
