Process Safety and Environmental Protection

Analysis of a gas explosion in Dimock PA (USA) during fracking operations in the Marcellus gas shale

Terry Engelder^{a,*}, John F. Zevenbergen^b

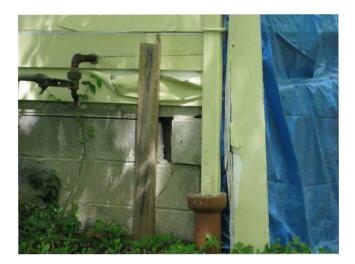
Fig. 1. Methane explosion in basement of house causing damage to the foundation in Chagrin Falls, Ohio, USA (Bair et al., 2012). The foundation has been cracked and paint peeled just above the vent points in the foundation.

A third event that has considerable similarities with Dimock comes from Chagrin Falls, OH, USA, where gas migrated up a water well and mixed with air at explosive levels in a basement (Bair et al., 2012). The natural gas – air mixture was ignited with the resulting pressure wave lifting one end of the home from its foundation just enough to jostle some concrete foundation blocks (Fig. 1). Heat from the venting flame peeled paint from the outer wall of the home but did not cause a fire. This natural gas - air deflagration could be traced back to methane migrating into the local water table from the outside of an incorrectly cemented casing of a nearby gas well less than 300 m to the south. The difference between the Dimock and Chagrin Falls gas wells is that in the former case the top of the open hole was 468 m below the surface in a 2271 m deep Marcellus gas shale well, whereas in the latter case the top of the open hole was 80 m below the surface in a 1197 m deep Clinton sandstone well, a conventional well.

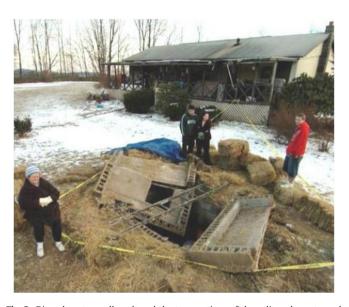
Fig. 2. Dimock water well vault and the two sections of the split and overturned concrete slab with the top course of concrete blocks still attached. View looking to the southeast. A reporter from the Scranton Times-Tribune appeared with a photographer the morning after the event in question (Legere, 2009). The reporter believes that the broken concrete slab had not been moved between the time of the January 1st 'explosion' and the time of this photograph was taken less than 24h later (L. Legere, 2013, personal communication).

The concrete slab with one course of concrete blocks still attached was split during an upward acceleration with the two pieces subsequently overturning before coming to rest. Two-thirds of the slab was thrown eastward and the remaining one-third was thrown westward (Fig. 3).

The western third may have been overturned with the western wall of the vault acting as a fulcrum. More than 50% of the eastern two-thirds of the slab landed back on top of the vault which means that the outside edge of the eastern slab did not turn on a fulcrum but rather was lifted clear of the vault and spun in space before dropping back down. The lifting forces were uneven as indicated
