# Rolling contact fatigue in relation to rail grinding

Michaël Steenbergen\*

Delft University of Technology, Faculty of Civil Engineering and Geosciences, Railway Engineering Group, Stevinweg 1, 2628 CN Delft, The Netherlands

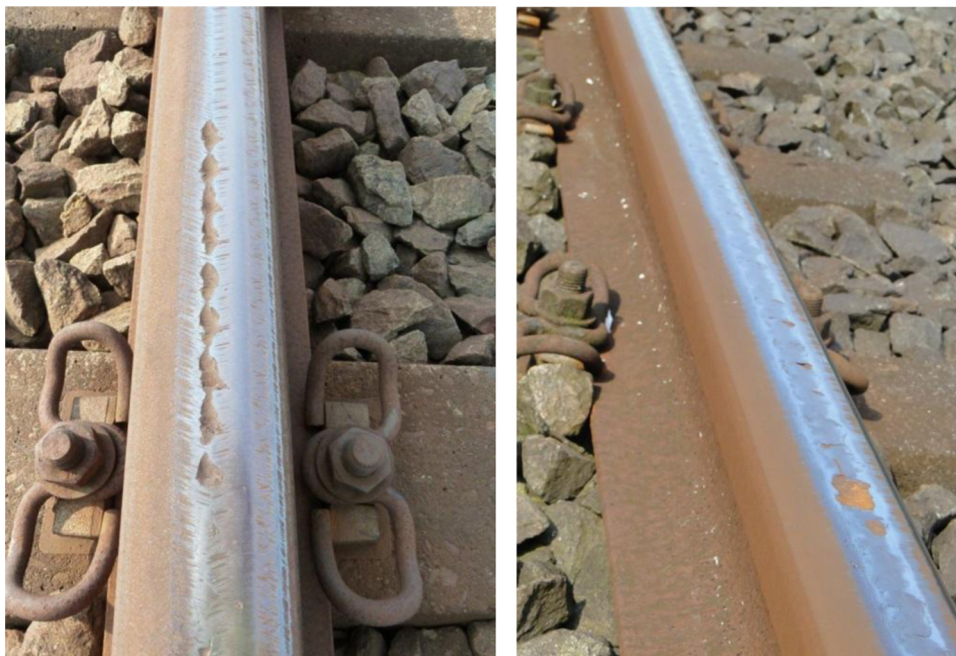
Recently, an increase in the number of particular rail spalling defects has been noticed on the Dutch rail network. The defects occur typically on heat-treated grades such as MHH (produced by Tata and belonging to the category R370crHT according to the European norm [1]). At first glance, it seems to concern a hybrid defect type with properties of both short-pitch corrugation and rolling contact fatigue (RCF). The defects are characterised by their affected length (with in some cases up to several hundreds of metres of affected rail), by the periodicity in the geometry of the defect, and by the fact that the cracks associated with the defects propagate systematically in the subsurface and do not develop deep into the railhead, leading to transverse defects. Examples are shown in Fig. 1.

Fig. 1. Periodic spalling defects on heat-treated rail grade R370crHT/MHH.

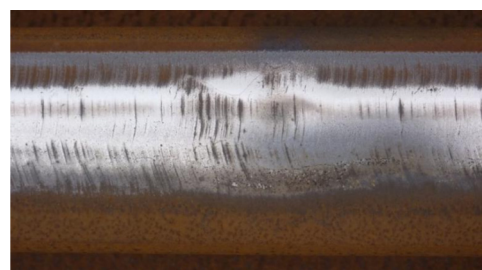
Fig. 2. A squat ground to an insufficient depth.
