# Nuisance tripping of residual current circuit breakers: A practical case

This article presents an investigation of the causes of false tripping in the La Fe Hospital in Valencia. Section 2 summarizes the basic checks carried out and the laboratory analysis using distorted waveforms. Transients detected in the connection and the disconnection of some receptors is discussed in Section 3. Section 4 details the design of a test system installed at the site that finally enabled the detection of the origin of the problem. Section 5 presents the measurements and results. Finally, some conclusions are drawn in Section 6.

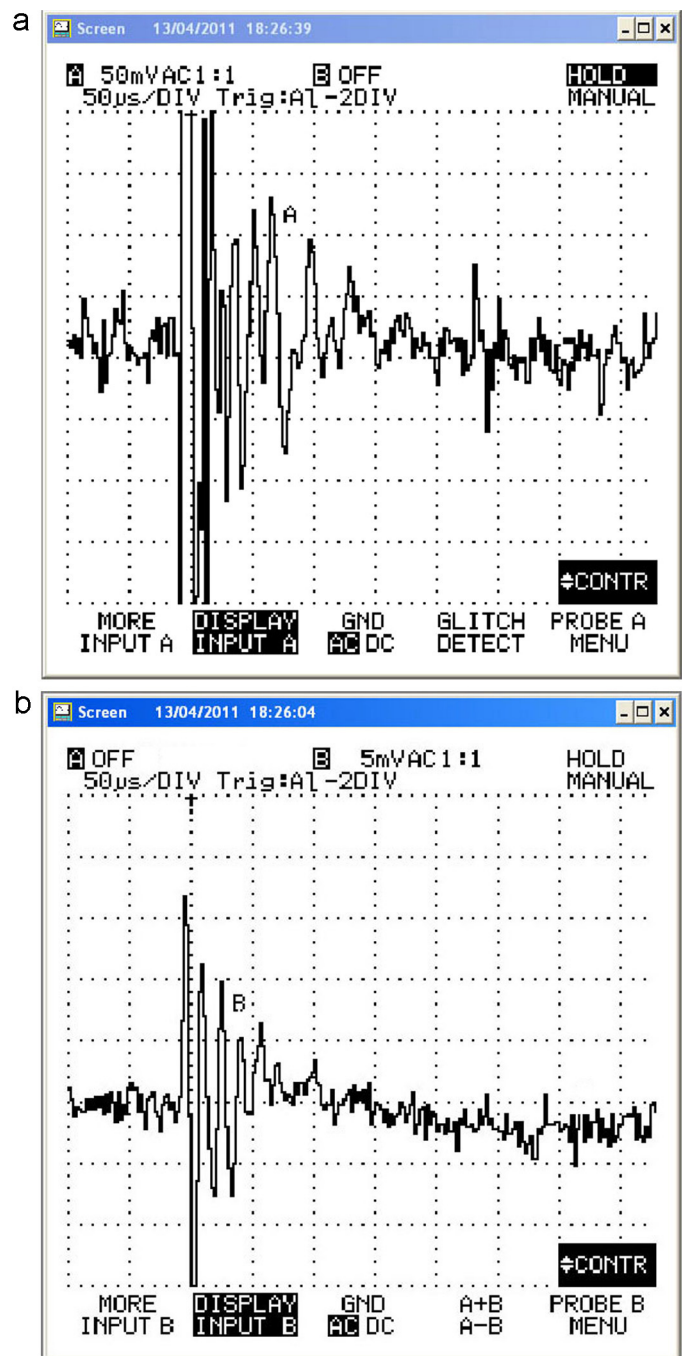
The connections and disconnections of these loads produced high frequency voltage transients in the RCCB tripping coil of several volts in amplitude, with currents of more than 150 mA in amplitude (Fig. 1). Likewise, transient residual currents of more than 500 mA in amplitude were detected. Although these effects are clearly detectable, the high frequency of disturbances (between 30 and 50 kHz) makes RCCBs very insensitive and do not trip. So this phenomenon was not the cause of the tripping of the AC RCCBs.

Fig. 1. Transients detected by turning off the lights in a room. The voltage in the tripping coil (a) is over 200 mV peak (50 mV per division) and the residual current (b) exceeds 150 mA peak (50 mA per division).
