Electric Power Systems Research

Investigation of diode rectifier trouble by lightning in D.C. traction substation

On August 17th, 2012, a diode rectifier at Nagano Traction Substation was broken. The broken rectifier was dismantled and investigated in detail and, as a result, it was estimated that the overvoltage caused by the lightning flash caused the dielectric breakdown in the rectifier. To confirm the assumption of the broken process, the field measurement at Nagano Traction Substation and FDTD (finite-difference time-domain) calculation analysis at Nagoya Institute of Technology were carried out. As a result, it was indicated that the direct lightning to the elevated bridge over the substation caused the transient overvoltage of the grounding system of the substation and resulted in the breakdown within the rectifier. Because the concrete bridge pier is located adjacent to the substation, the surge voltage from the elevated bridge is able to influence the potential of the substation mesh. In this paper, the investigation process to determine the cause of the trouble will be shown in detail.

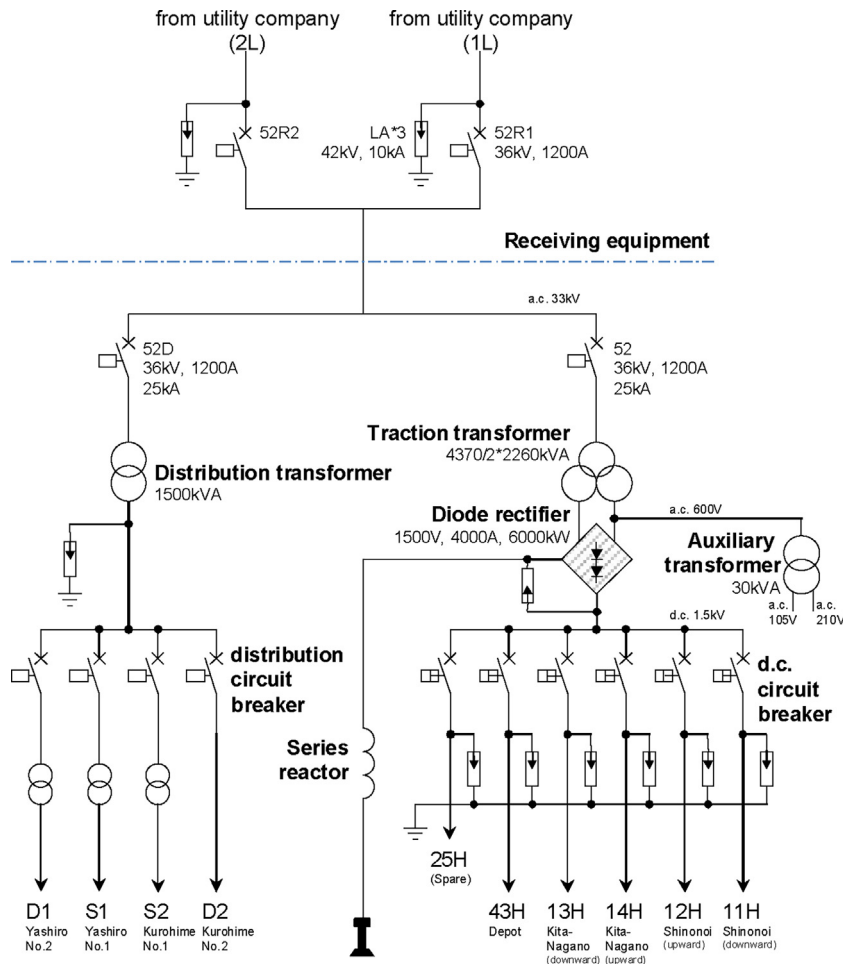
Fig. 1. Skeleton diagram of Nagano SS.

Fig. 2 shows the skeleton diagram of Nagano Substation and the broken rectifier is indicated as a shadow hatching box in this figure [9]. When the rectifier was broken, a lot of lightning flash strokes were observed around the substation and it was estimated that the breakdown of the rectifier was caused by lightning. The location of the rectifier was, however, under the elevated bridge for the high speed railway and the electric machines of Nagano Substation for conventional railway was completely shielded from lightning as shown in Fig. 2 [10], and the electric machines of Nagano Substation are electrically independent from the catenaries system for high speed railway on the elevated bridge. The grounding down conductor of grounding wire on the elevated bridge, however, leads to the ground along the pier adjacent to the Nagano Substation.

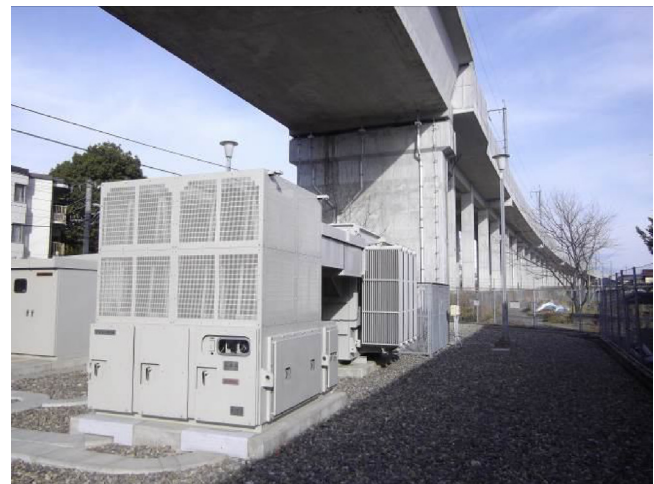
Fig. 2. Installation condition of rectifier.

Judging from such a location of the broken rectifier, the procedure of the breakdown was estimated as follows:

- A lightning flash hit the overhead grounding wire of the catenaries for high speed railway on the elevated bridge.
- The lightning surge went through the down conductor in the bridge pier and was released to the ground.
