## Materials Science in Semiconductor Processing

## Mechanism and detection of poly gate leakage with nonvisual defects by voltage contrast inspection

The research aims at nonvisual defects causing the poly gate leakage failure and the corresponding inline voltage-contrast (VC) inspection. Electron beam inspection (EBI) begins to be frequently used for scanning either SRAM or DRAM cell area in nano-scaled technologies. The research, furthermore, extends EBI to logical area of an ASIC product and proposes an inline detectable methodology for gate leakages. Extreme tiny and nonvisual residues could happen during gate etch processes by the step height between active area (AA) and shallow trench isolation (STI), and the tiny defects are difficult to be located even some of those did lead to chip probe (CP) test failure. The subsequent implant processes would punch through those tiny poly residues, make the residue being conductive, and finally electrons on the gate would leak to the ground through the residue. Those nonvisual residues act as bridges for gate leakages. EBI with designed positive charging modes was applied into the series of implement steps and found the leakage by a s

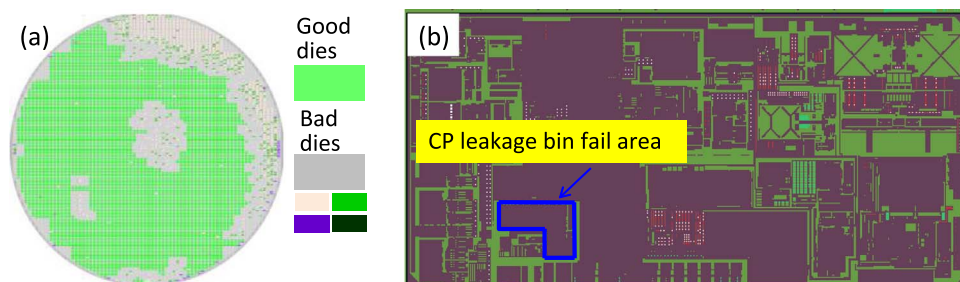
In the initial stage of volume production of an ASIC (Application Specific Integrated Circuit) product in a 300 mm fab, a repeating low yield issue with leakage related bins was reported by the end-of-line CP test. The map distribution of the failure chips, as shown in Fig. 1(a), was a shape of donut at both wafer center and edge. With the failure bin corresponding modules, an area contented logical circuits was marked as shown in Fig. 1(b). And that's it; the information is far from enough to address the exact failure location in the nano-metre world. Even the reverse engineering had been executed; the delayering PFA (physical failure analysis) did not find abnormality in the logical block. This is a continual suffering event; however, the traditional analysis method cannot address the cause. Each of inline and end-of-the-line parameters, involving WAT (wafer acceptance test), process commonality, CD (critical dimension), thickness, and etc. were pull out and checked. All process parameters were under control, and the defect source cannot be found.

Fig. 1. (a) CP yield map and (b) the leakage bin corresponding area within the chip.
